Rt. 47/Hadley Street and Titan Pier Road at Dry Brook Culvert Replacement Concept South Hadley, MA

Rt. 47/Hadley Road and Titan Pier Road Culvert Replacement Concepts, South Hadley, MA

Culvert Replacement Concepts, South Hadley, MA

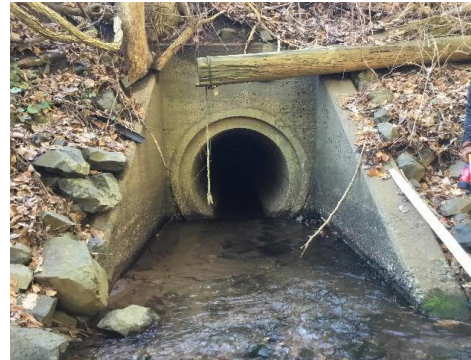
Image 1: Existing structure inlet during field visit on November 24, 2020.

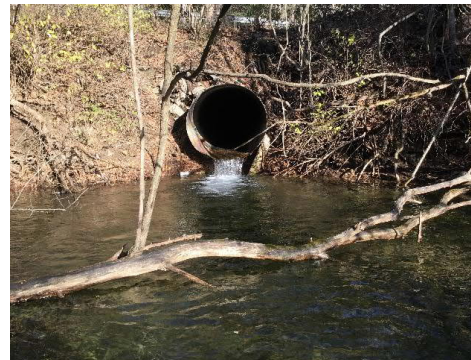
Image 2: Existing structure outlet during field visit on November 24, 2020. Note the large scour pool, eroded banks, and perched outlet. Also note the change from concrete at the inlet to corrugated metal at the outlet.

- High potential for transportation disruption and flood impact potential
- Severe constriction
- Structure changes material, size, and direction between inlet and outlet

- Replace the existing metal pipe culvert with an open-bottom arch with a span of approximately 22 feet to accommodate a future estimated bankfull width of approximately 17.4 feet associated with an estimated 20% increase in bankfull flows due to climate change,
 - This will result in a crossing that meets the Massachusetts River and Stream Crossing Standards, which require a span of 1.2 times the stream's bankfull width.
- The proposed culvert replacement design concept will:
 - Provide increased hydraulic capacity to reduce flooding risk and to allow water and debris associated with larger storms to pass.
 - Decrease potential for road overtopping during heavy precipitation.
 - Reduce geomorphic risk by realigning the culvert and eliminating changes in structure material and dimensions.
 - Improve the passability of the structure

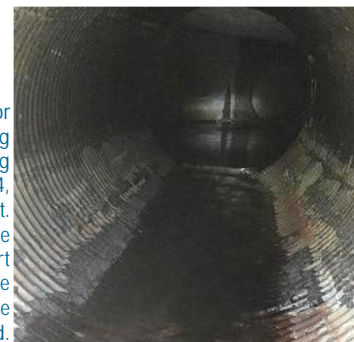
Image 4: Interior of the existing culvert during November 24, 2020 field visit. Note the change in culvert alignment at the chamber in the background.

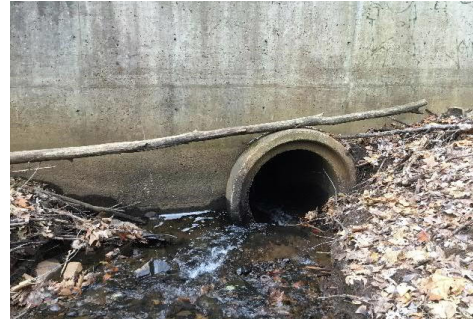
Image 1: Existing structure inlet during field visit on November 25, 2020. Note the inlet drop and misalignment of the stream with the inlet.

- Realign the crossing and replace the existing culvert with an open-bottom arch or three-sided box culvert with a span of approximately 16 feet to accommodate a future estimated bankfull width of approximately 12.2 feet associated with an estimated 20% increase in bankfull flows due to climate change.
 - This will result in a crossing that meets the Massachusetts River and Stream Crossing Standards, which require a span of 1.2 times the stream's bankfull width.
- The proposed culvert replacement design concept will:
 - Relieve constriction and reduce potential for scour and erosion
 - Reduce geomorphic risk by realigning the culvert
 - Improve the passability of the structure

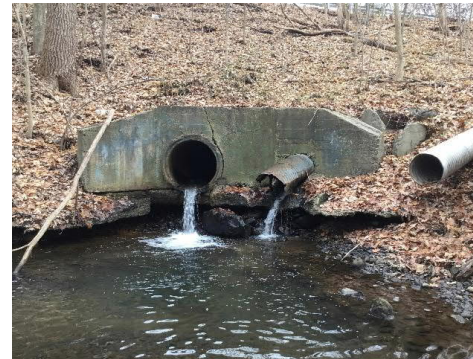
Image 2: Existing structure outlet during field visit on November 25, 2020. Note the large scour pool, severely eroded banks and undermined endwall, and perched outlet. Also note the two perched stormwater pipes (to the right of the outlet in this photo).

- Severe scour at the outlet has undermined the endwall and caused the formation of sinkholes and a large scour pool
- High flood impact potential
- Critical structural deficiencies include culvert blockage, embankment piping, and poor structural integrity and alignment

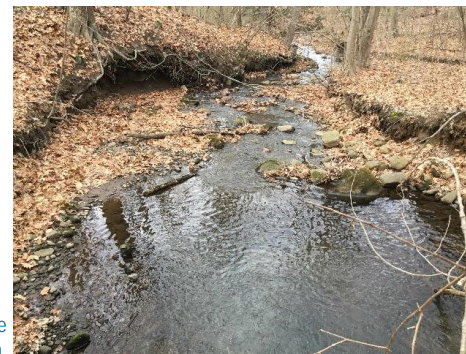
Image 4: View downstream of the culvert outlet during the November 25, 2020 field visit. Note the severe bank erosion.

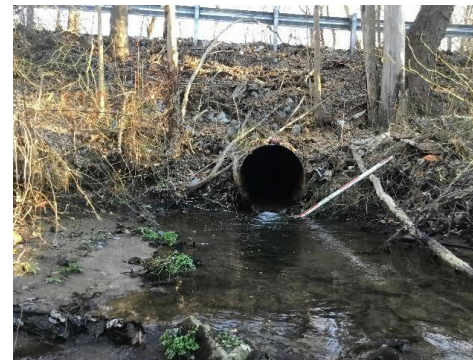
Image 2: Existing structure outlet during field visit on December 4, 2020. Note the large scour pool, eroded banks, and perched outlet.

Restore Existing Tailwater Scour Pool to Recreate Natural Channel

Restore Eroded Banks

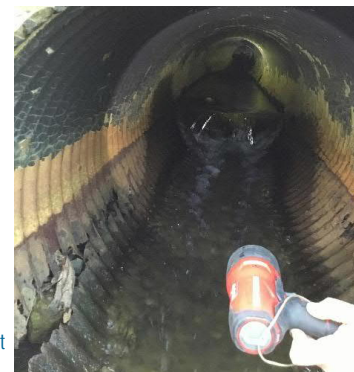
Image 4: Interior of the existing culvert during December 4, 2020 field visit. The culvert is poorly aligned and rusted through, and a blockage has formed inside the barrel.

- High flood impact potential
- Severe constriction
- Critical structural deficiencies include culvert blockage, embankment piping, and poor structural integrity and alignment

- Realign the crossing and replace the existing culvert with a three-sided box culvert with a span of approximately 12 feet to accommodate a future estimated bankfull width of approximately 9 feet associated with a 20% increase in bankfull flows due to climate change
 - This will result in a crossing that meets the Massachusetts River and Stream Crossing Standards, which require a span of 1.2 times the stream's bankfull width.
- The proposed culvert replacement design concept will:
 - Provide increased hydraulic capacity to reduce flooding risk and to allow water and debris associated with larger storms to pass.
 - Decrease potential for road overtopping during heavy precipitation.
 - Reduce geomorphic risk by realigning the culvert
 - Improve the passability of the structure

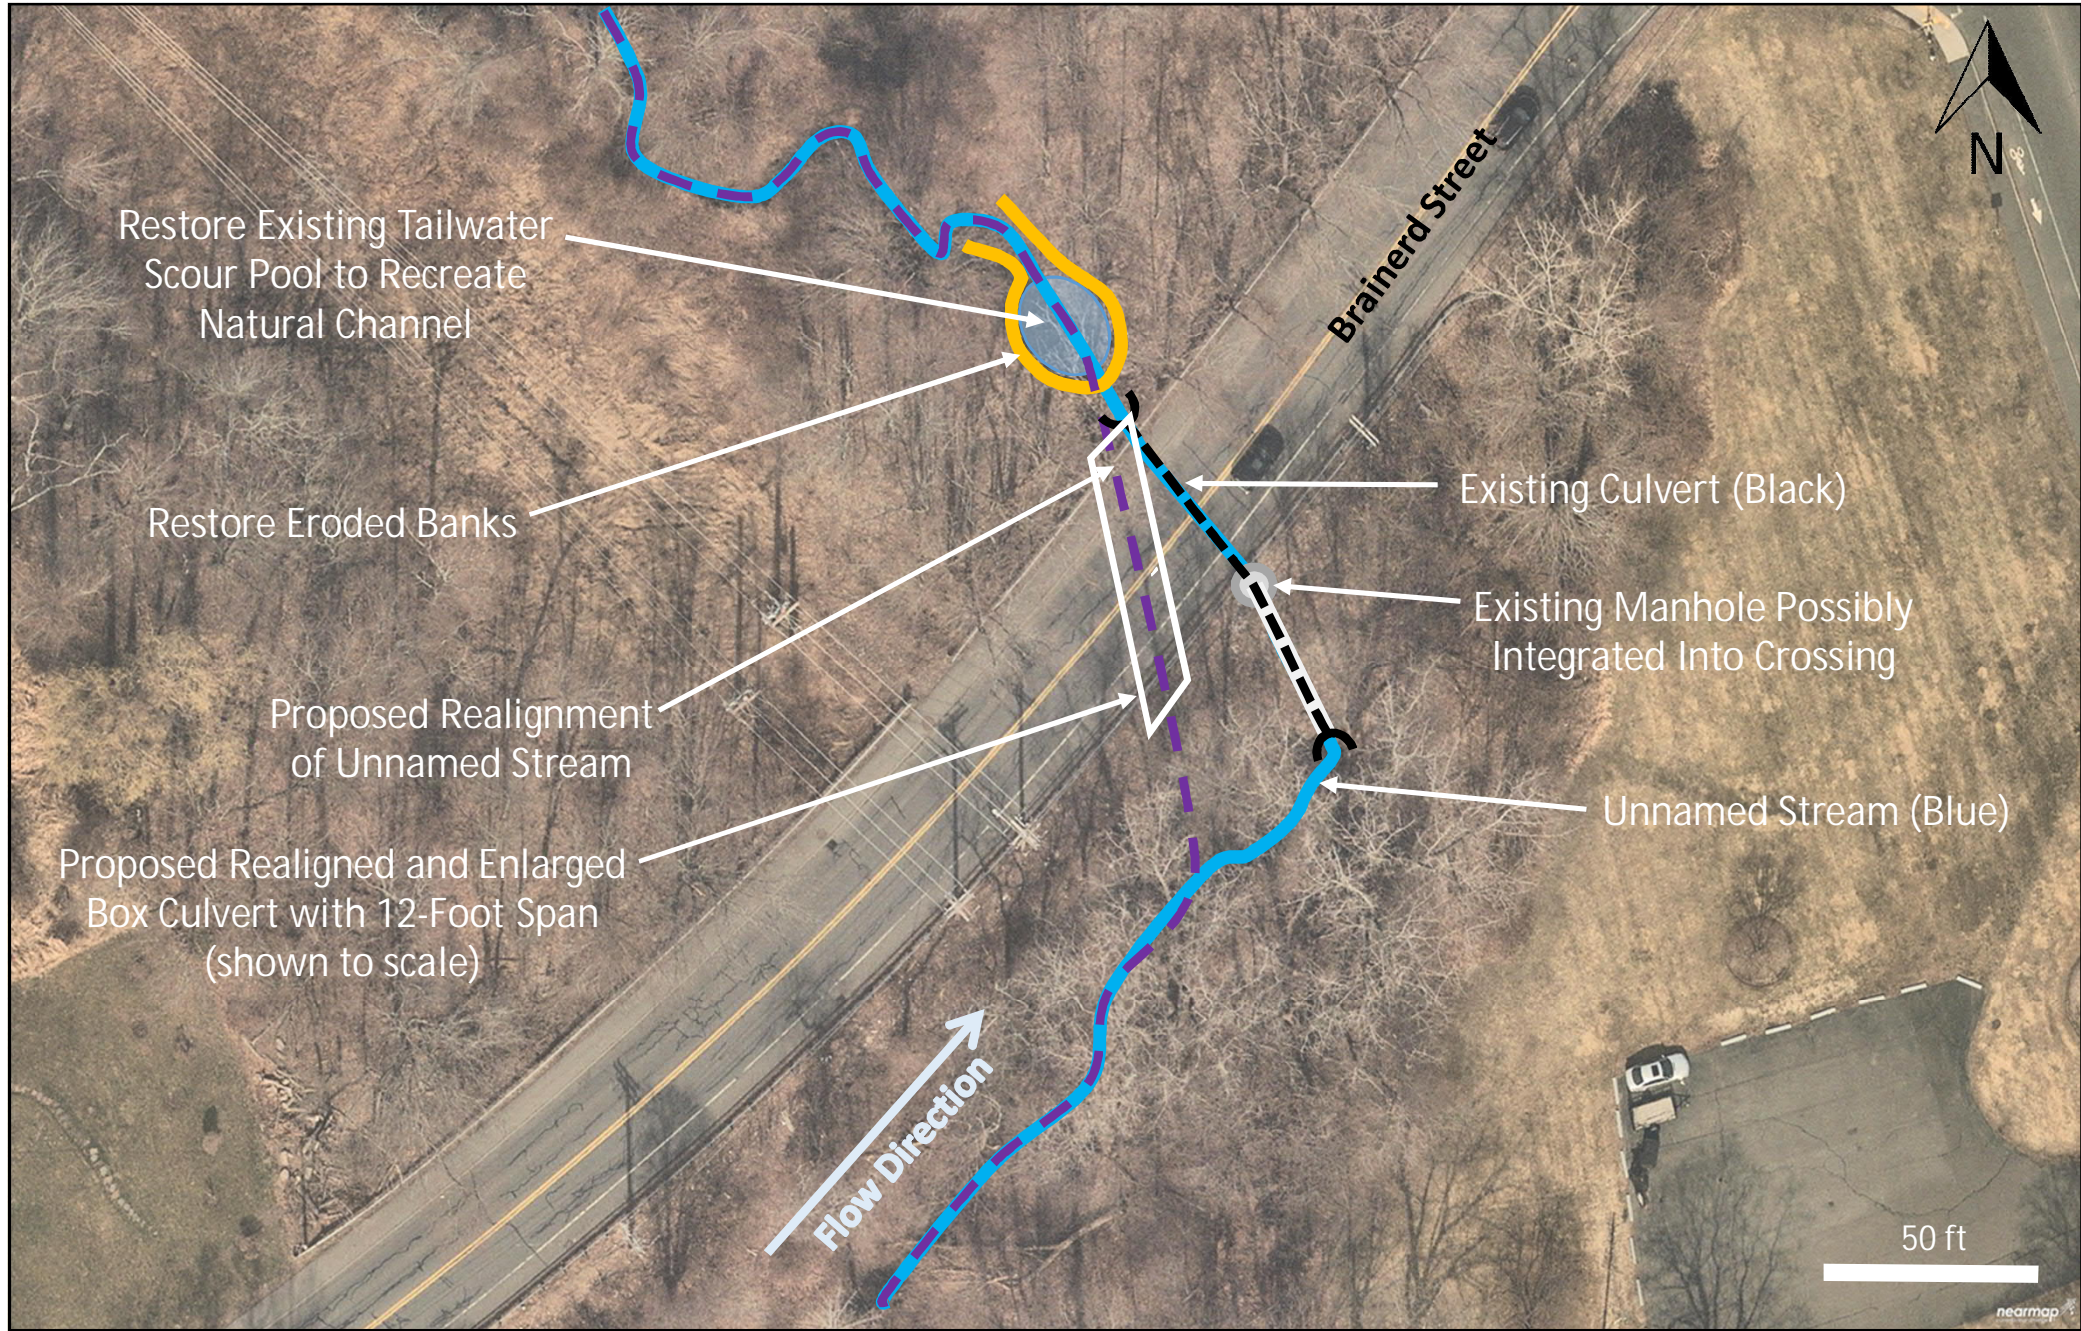
Existing Culvert (Black)

Existing Manhole Possibly Integrated Into Crossing

Proposed Realignment of Unnamed Stream

Proposed Realigned and Enlarged Box Culvert with 12-Foot Span (shown to scale)

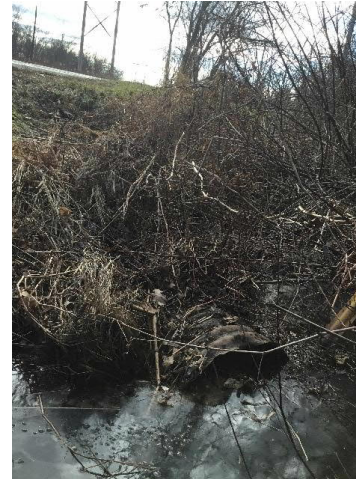
Image 1: Existing structure inlet during field visit on December 10, 2020. Note the sediment deposition blocking the projecting inlet.

- Replace the existing culverts with three-sided box culverts with spans of approximately 9 feet to accommodate a future estimated bankfull width of approximately 6.9-7.5 feet associated with an estimated 20% increase in bankfull flows due to climate change,

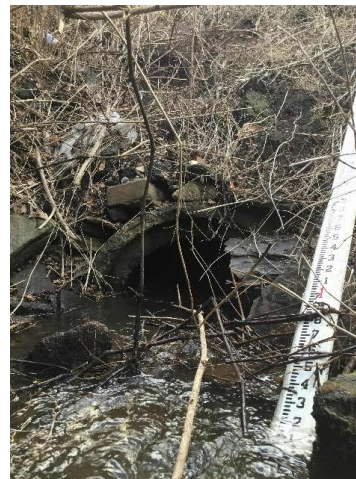
Image 2: Existing Brainerd Street culvert inlet during field visit on December 10, 2020.

- High flood impact potential
- High hydraulic and geomorphic risk at Lathrop Street culvert due to small diameter and angle of culvert to stream
- Cedar Ridge culvert integrated with stormwater drainage
- Sinkhole forming and outlet submerged at Brainerd St.

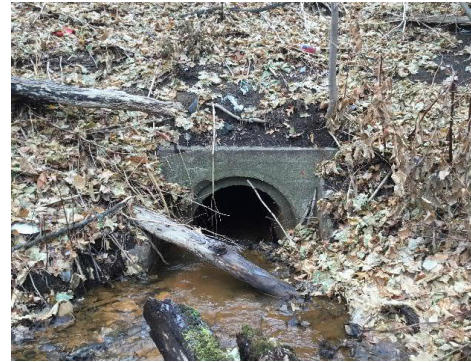
Image 1: Existing structure inlet during field visit on November 25, 2020, showing a blockage causing a drop into the inlet and erosion of the banks to either side.

- Realign the crossing to the north of the existing crossing to create a straight structure that avoids the manhole and the three wells at the structure outlet and eliminates the bends in the stream channel at the culvert inlet and outlet.

- Replace the existing culvert with a bridge, open-bottom arch, or three-sided box culvert with a span of approximately 26 feet, to accommodate a future estimated bankfull width of approximately 21.5 feet associated with a 20% increase in bankfull flows due to climate change

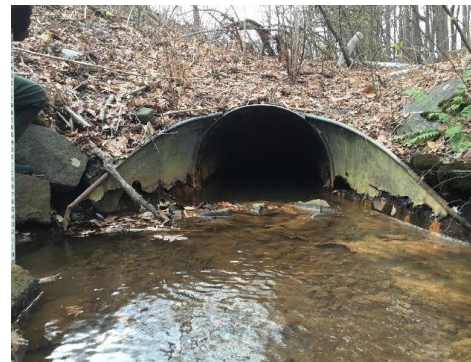
Image 2: Existing structure outlet during field visit on November 25, 2020. Note the gaps on either side of the culvert where erosion and piping may be occurring and the damage to the flared end section.

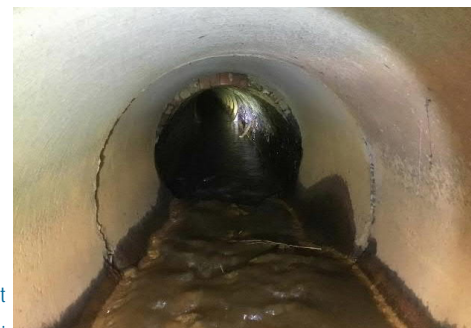
Image 4: Interior of the existing culvert during November 25, 2020 field visit. The culvert is poorly aligned and constructed of three different types of structural material.

- High flood impact potential and potential for transportation disruption and
- Structure changes material, size, and direction between inlet and outlet
- The structure outlet is located near three wells whose purpose is unknown

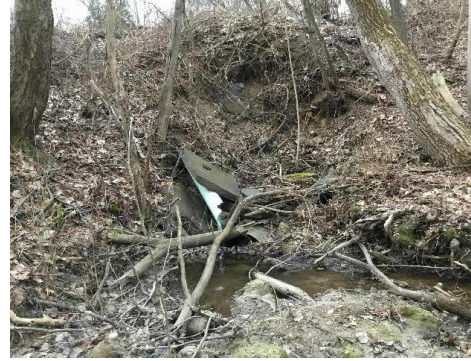
Image 1: Existing structure inlet during field visit on December 9, 2020, showing a blockage at the inlet and the collapsed bank above the pipe.

- Realign the crossing and replace the existing culvert with an open-bottom arch with a span of approximately 8 feet to accommodate a future estimated bankfull width of approximately 6.5 feet associated with an estimated 20% increase in bankfull flows due to climate change,
 - This will result in a crossing that meets the Massachusetts River and Stream Crossing Standards, which require a span of 1.2 times the stream's bankfull width.
- The proposed culvert replacement design concept will:
 - Provide increased hydraulic capacity to reduce flooding risk and to allow water and debris associated with larger storms to pass.
 - Decrease potential for road overtopping during heavy precipitation.
 - Reduce geomorphic risk by alleviating the constriction.
 - Improve the passability of the structure.

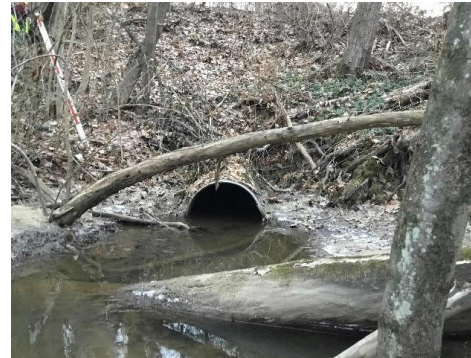
Image 2: Existing structure outlet during field visit on December 9, 2020. Note the severely eroded banks.

- High flood impact potential
- Severe constriction
- Severe bank erosion and collapse at the inlet and outlet

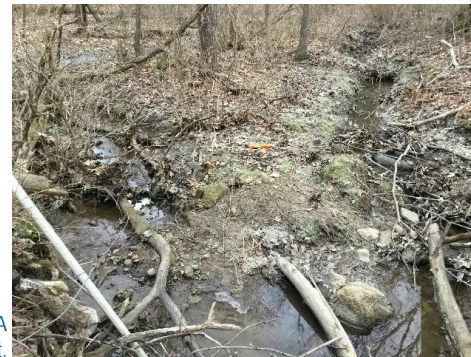
Image 4: The upstream channel during the December 9, 2020 field visit. A sediment bar has formed and split the channel upstream of the inlet.

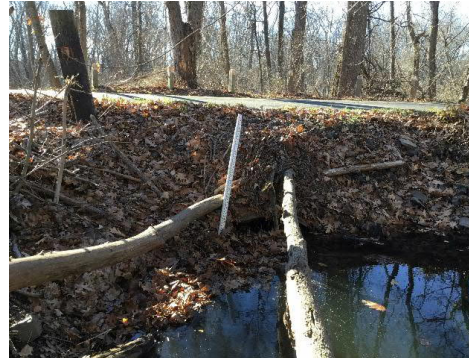
Image 1: Existing structure inlet during field visit on December 10, 2020, showing only the top of the pipe. The rest of the inlet is buried under sediment and debris.

- Replace the existing culvert with a bridge, open-bottom arch, or three-sided box culvert with a span of approximately 18 feet to accommodate an estimated future bankfull width of approximately 14 feet associated with an estimated 20% increase in bankfull flows due to climate change,

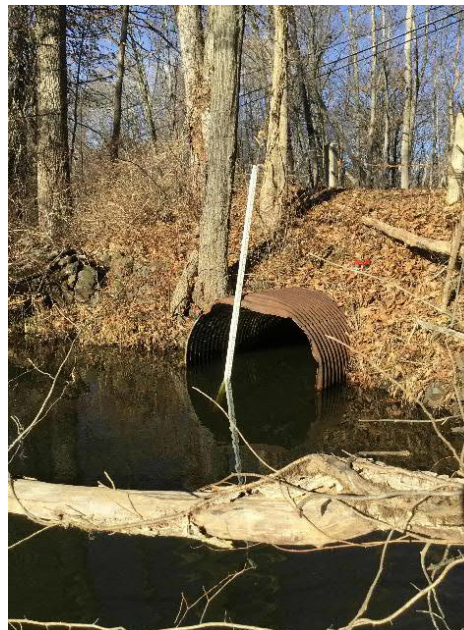
Image 2: Existing structure outlet during field visit on December 10, 2020.

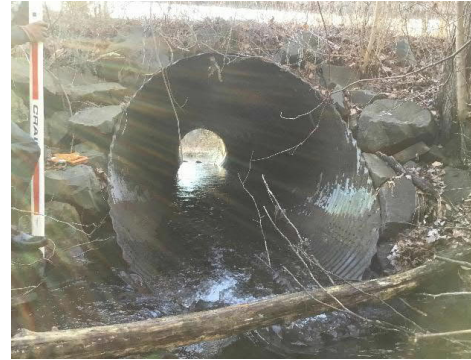
Image 1: Existing structure inlet during field visit on November 24, 2020.
