MEMORANDUM

DATE: June 1, 2021

RE: Town-Wide Road-Stream Crossing Assessment – MVP Action Grant
Road-Stream Crossing Assessment Technical Memorandum

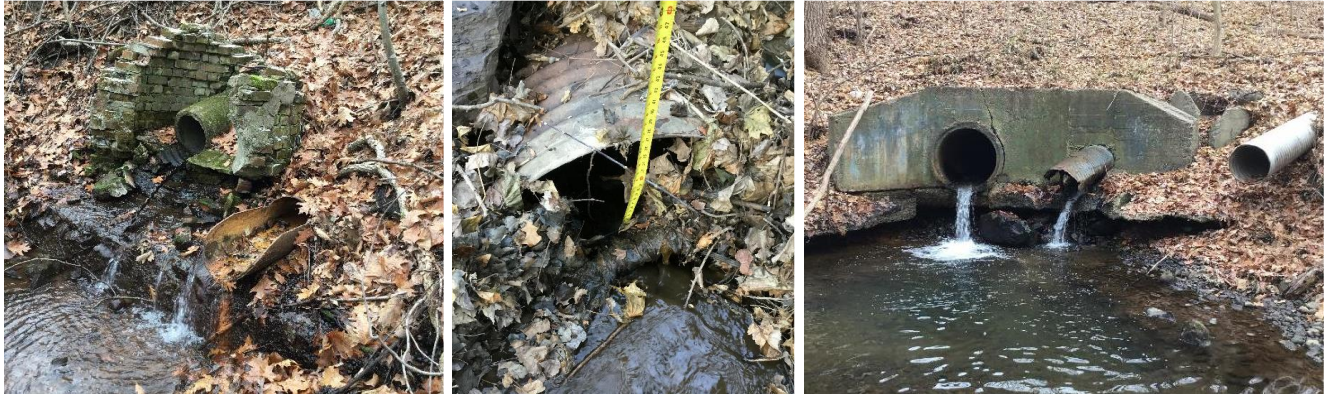
- **Poor Structural Condition:** Approximately one third of the crossings were observed to be in poor condition and in need of significant repairs or replacement. The most common critical structural deficiency was poor longitudinal alignment of the culvert, sometimes due to shifting of the culvert barrel or installation of another structure along the culvert alignment (this is common, e.g., when an existing culvert has been extended due to the widening of a road). Damage to the joints and seams, structural integrity, embankment piping and loss of armoring was also observed at many of these crossings. See **Figure 3** for examples of crossings in poor structural condition.

Figure 3. Examples of crossing structures in poor structural condition observed at various locations during field assessments.

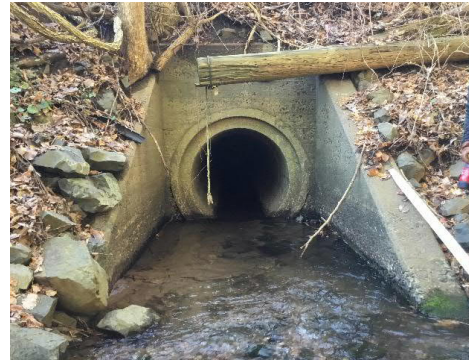
Image 1: Existing structure inlet during field visit on November 24, 2020.

- Replace the existing metal pipe culvert with an open-bottom arch with a span of approximately 22 feet to accommodate a future estimated bankfull width of approximately 17.4 feet associated with an estimated 20% increase in bankfull flows due to climate change,
 - This will result in a crossing that meets the Massachusetts River and Stream Crossing Standards, which require a span of 1.2 times the stream's bankfull width.
- The proposed culvert replacement design concept will:
 - Provide increased hydraulic capacity to reduce flooding risk and to allow water and debris associated with larger storms to pass.
 - Decrease potential for road overtopping during heavy precipitation.
 - Reduce geomorphic risk by realigning the culvert and eliminating changes in structure material and dimensions.
 - Improve the passability of the structure

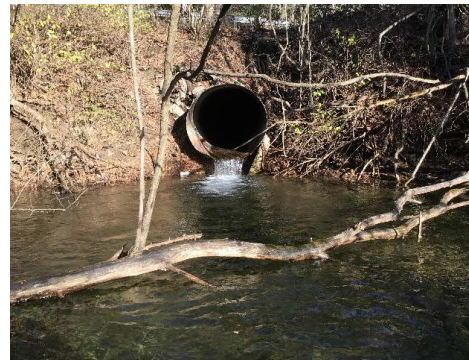
Image 2: Existing structure outlet during field visit on November 24, 2020. Note the large scour pool, eroded banks, and perched outlet. Also note the change from concrete at the inlet to corrugated metal at the outlet.

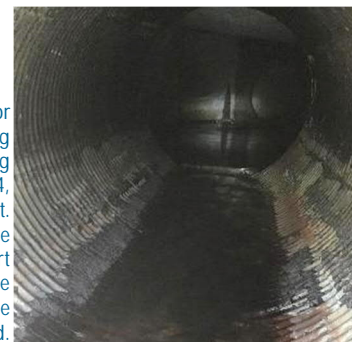
Image 4: Interior of the existing culvert during November 24, 2020 field visit. Note the change in culvert alignment at the chamber in the background.

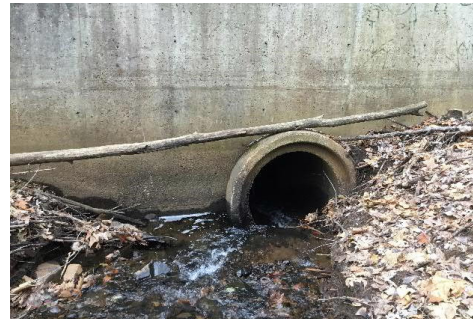
Image 1: Existing structure inlet during field visit on November 25, 2020. Note the inlet drop and misalignment of the stream with the inlet.

- Realign the crossing and replace the existing culvert with an open-bottom arch or three-sided box culvert with a span of approximately 16 feet to accommodate a future estimated bankfull width of approximately 12.2 feet associated with an estimated 20% increase in bankfull flows due to climate change.
 - This will result in a crossing that meets the Massachusetts River and Stream Crossing Standards, which require a span of 1.2 times the stream's bankfull width.
- The proposed culvert replacement design concept will:
 - Relieve constriction and reduce potential for scour and erosion
 - Reduce geomorphic risk by realigning the culvert
 - Improve the passability of the structure

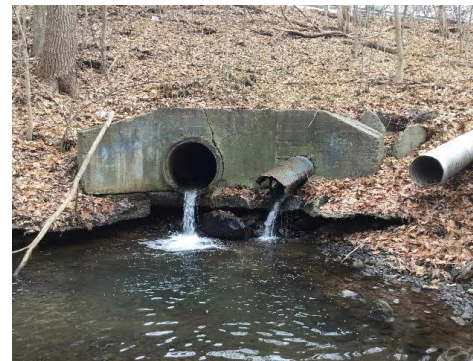
Image 2: Existing structure outlet during field visit on November 25, 2020. Note the large scour pool, severely eroded banks and undermined endwall, and perched outlet. Also note the two perched stormwater pipes (to the right of the outlet in this photo).

- Severe scour at the outlet has undermined the endwall and caused the formation of sinkholes and a large scour pool
- High flood impact potential
- Critical structural deficiencies include culvert blockage, embankment piping, and poor structural integrity and alignment

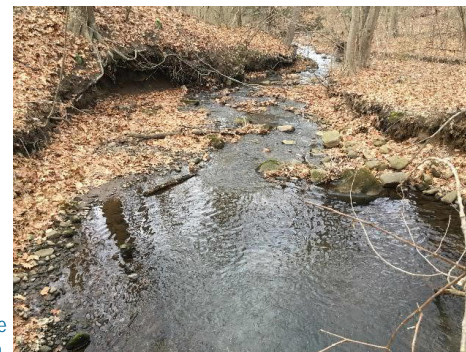
Image 4: View downstream of the culvert outlet during the November 25, 2020 field visit. Note the severe bank erosion.

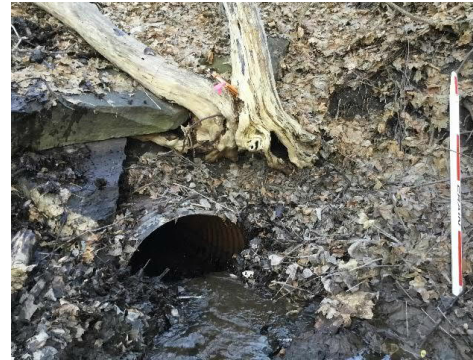
Image 1: Existing structure inlet during field visit on December 4, 2020, showing a blockage causing a drop into the inlet and erosion on the bank above the pipe.

- Realign the crossing and replace the existing culvert with a three-sided box culvert with a span of approximately 12 feet to accommodate a future estimated bankfull width of approximately 9 feet associated with a 20% increase in bankfull flows due to climate change
 - This will result in a crossing that meets the Massachusetts River and Stream Crossing Standards, which require a span of 1.2 times the stream's bankfull width.
- The proposed culvert replacement design concept will:
 - Provide increased hydraulic capacity to reduce flooding risk and to allow water and debris associated with larger storms to pass.
 - Decrease potential for road overtopping during heavy precipitation.
 - Reduce geomorphic risk by realigning the culvert
 - Improve the passability of the structure

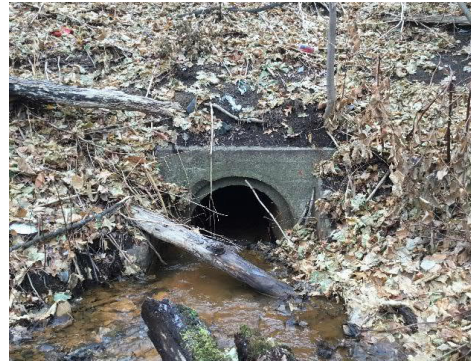
Image 1: Existing structure inlet during field visit on November 25, 2020, showing a blockage causing a drop into the inlet and erosion of the banks to either side.

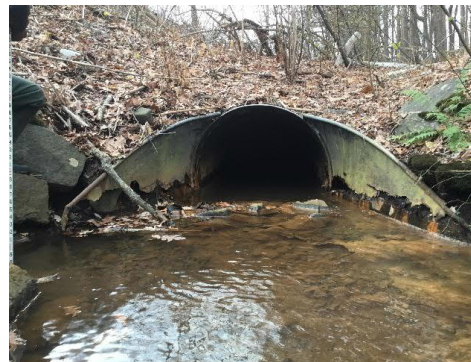
Willimansett Street crosses Buttery Brook approximately 240 feet north of its intersection with Hollywood Street and Memorial Drive. The existing structure is a round pipe constructed of concrete at the inlet and corrugated metal at the outlet with brick near the middle of the structure. The culvert diameter is approximately 3 feet at the inlet, resulting in a severe constriction of the stream's approximately 20-foot bankfull width. The crossing is undersized for all peak flows assessed under existing and future climate conditions. Noted structural deficiencies include embankment piping, poor structure alignment, loss of structural integrity, spreading of culvert joints, and damage flared end section.

Image 2: Existing structure outlet during field visit on November 25, 2020. Note the gaps on either side of the culvert where erosion and piping may be occurring and the damage to the flared end section.

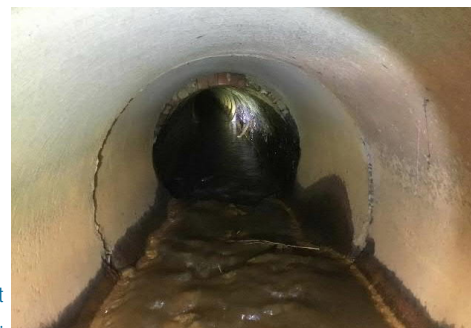
Image 4: Interior of the existing culvert during November 25, 2020 field visit. The culvert is poorly aligned and constructed of three different types of structural material.

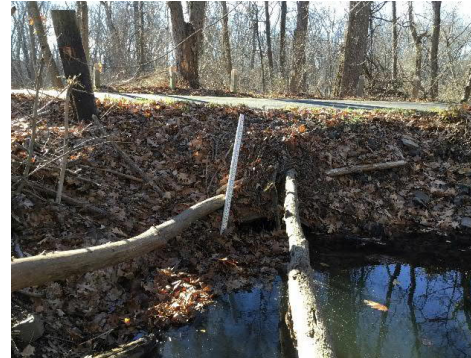
Image 1: Existing structure inlet during field visit on December 10, 2020, showing only the top of the pipe. The rest of the inlet is buried under sediment and debris.

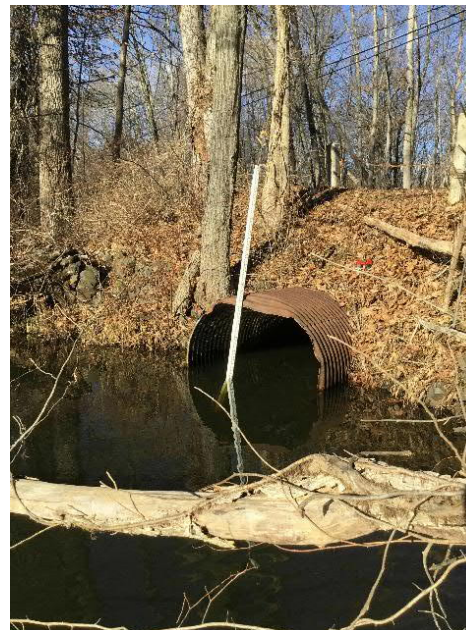
Image 2: Existing structure outlet during field visit on December 10, 2020.

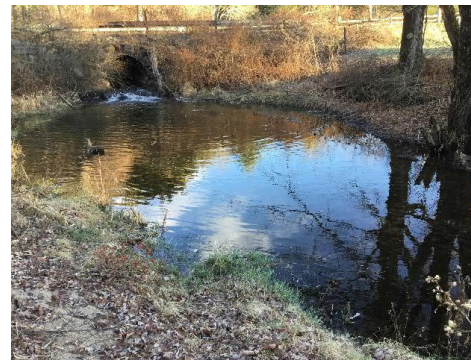
Image 2: Existing structure outlet during field visit on November 24, 2020. Note the large scour pool, eroded banks, and perched outlet.

- Bank stabilization will limit the loss of existing farmland
 - Nature-based solutions are low cost and require little maintenance.
 - Nature-based solutions provide additional benefits, including improved in-stream and riparian habitat and improved water quality.
