Municipal Vulnerability Preparedness (MVP) Action Grant: Queensville Dam Removal Feasibility Study & Buttery Brook Watershed Enhancements

This Climate Resiliency Update brought to you by the Planning & Conservation Department

Queensville Dam at Titus Pond

Wetland Delineation

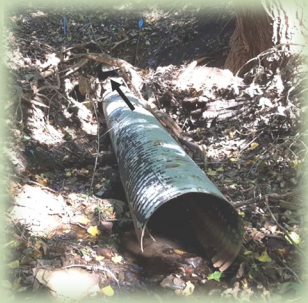
Culverts in this site are perched, clogged, or collapsing making aquatic passage impossible or very unlikely. The downstream road-stream crossings along Buttery Brook were assessed through the Town's FY21 Action Grant, and several of them were identified as high priority for redesign and replacement.

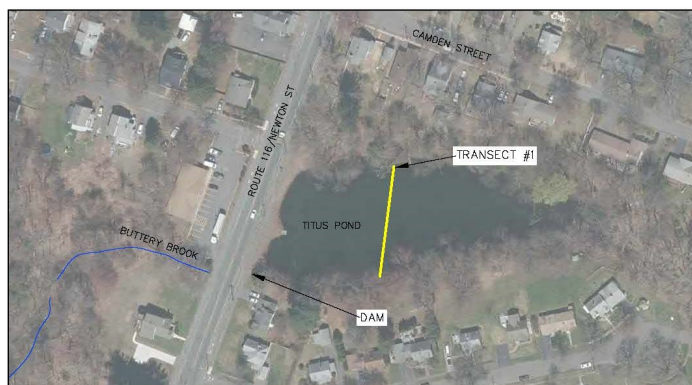
Three sediment boring samples were taken at north, center, and south points along one Transect. The general subsurface conditions as observed in the

borings included organic silt which was observed to be underlain by a native horizon consisting of sandy silt and/or fine sands. The borings observed consisted of a shallow horizon of sediment of approximately a foot in thickness. Results were below thresholds of applicable sediment standards for contaminants. The full results are available in the "Sediment Quality Memo" on the Climate Change Resiliency & Preparedness webpage.

Three soil borings were taken along Transect #1 across the middle of Titus Pond.
