MEMORANDUM

DATE: June 1, 2021

RE: Town-Wide Road-Stream Crossing Assessment – MVP Action Grant
Road-Stream Crossing Assessment Technical Memorandum

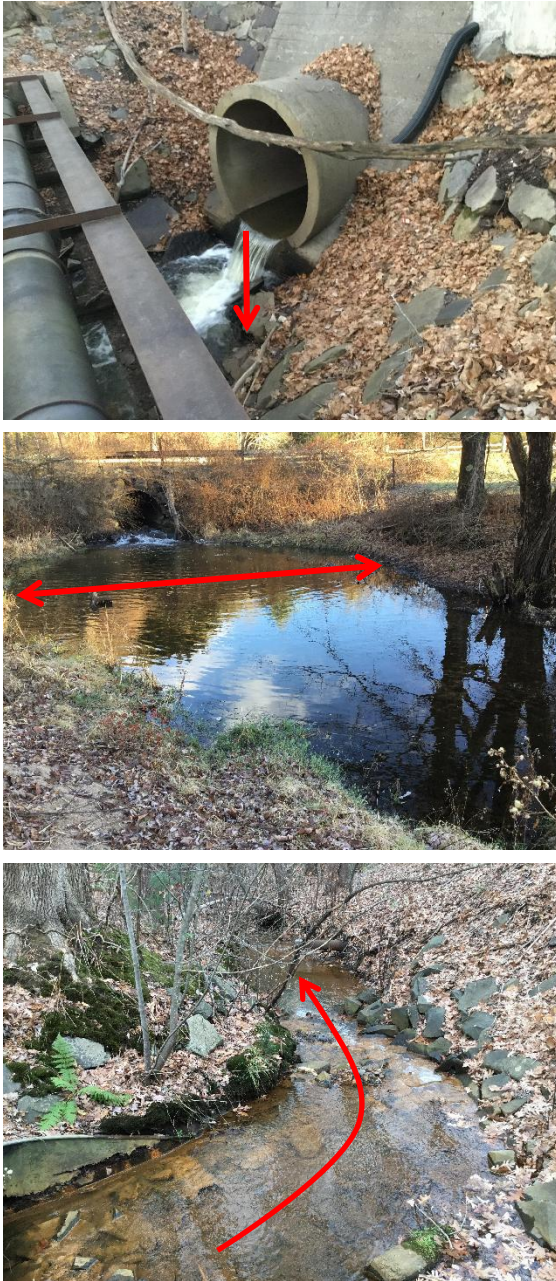
Figure 8. Geomorphic Vulnerability Ratings/Scores consider factors such as outlet drops which contribute to scour, the bankfull width of the stream, and alignment of the stream with the structure. The Main Street crossing over Buttery Brook (top) received a Geomorphic Vulnerability Score of 4 due to the free fall at the outlet as well as flow constriction and alignment factors. The Pearl Street crossing over Elmer Brook (middle) has a very wide tailwater scour pool at the outlet. The Willimansett Street crossing over Buttery Brook (bottom), where the stream bends immediately after leaving the outlet, demonstrates poor alignment of the crossing structure with the stream.

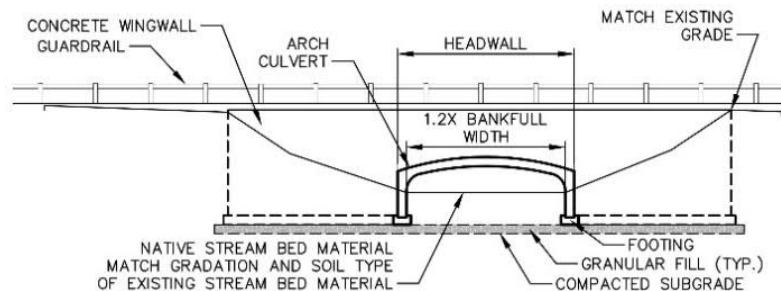
Image 3: Typical detail of an open arch culvert designed to meet MA Stream Crossing Standards

- Realign the crossing and replace the existing culvert with an open-bottom arch or three-sided box culvert with a span of approximately 16 feet to accommodate a future estimated bankfull width of approximately 12.2 feet associated with an estimated 20% increase in bankfull flows due to climate change.
 - This will result in a crossing that meets the Massachusetts River and Stream Crossing Standards, which require a span of 1.2 times the stream's bankfull width.
- The proposed culvert replacement design concept will:
 - Relieve constriction and reduce potential for scour and erosion
 - Reduce geomorphic risk by realigning the culvert
 - Improve the passability of the structure

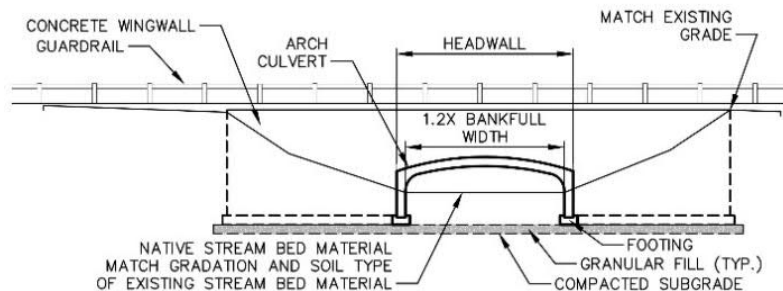
Image 3: Typical detail of an open arch culvert designed to meet MA Stream Crossing Standards

- Realign the crossing and replace the existing culvert with a three-sided box culvert with a span of approximately 12 feet to accommodate a future estimated bankfull width of approximately 9 feet associated with a 20% increase in bankfull flows due to climate change
 - This will result in a crossing that meets the Massachusetts River and Stream Crossing Standards, which require a span of 1.2 times the stream's bankfull width.
- The proposed culvert replacement design concept will:
 - Provide increased hydraulic capacity to reduce flooding risk and to allow water and debris associated with larger storms to pass.
 - Decrease potential for road overtopping during heavy precipitation.
 - Reduce geomorphic risk by realigning the culvert
 - Improve the passability of the structure

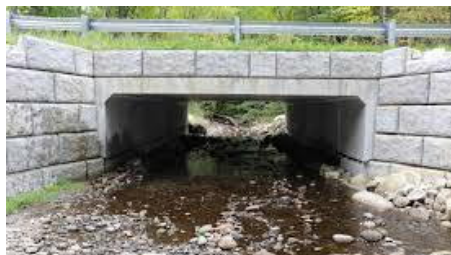
Image 3: Example of embedded box culvert (Maine Audubon).

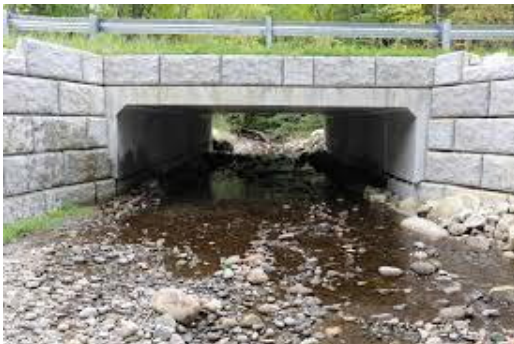
Image 3: Example of a box culvert (Maine Audubon).

- Provide increased hydraulic capacity to reduce flooding risk and to allow water and debris associated with larger storms to pass.
 - Decrease potential for road overtopping during heavy precipitation.

- Reduce geomorphic risk by realigning the Lathrop Street culvert
 - Provide an economy of scale when designing, permitting, and constructing the culvert replacements, reducing overall costs.

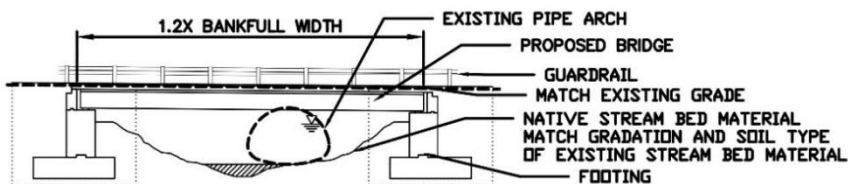
Image 3: Typical detail of a bridge designed to meet the MA River and Stream Crossing Standards.

- The proposed culvert replacement design concept will:
 - Provide increased hydraulic capacity to reduce flooding risk and to allow water and debris associated with larger storms to pass.

- Decrease potential for road overtopping during heavy precipitation.
 - Reduce geomorphic risk by realigning the culvert and eliminating changes in structure material and dimensions.

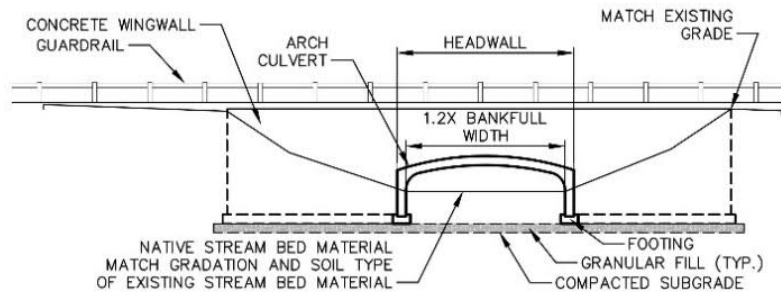
Image 3: Typical detail of an open arch culvert designed to meet MA Stream Crossing Standards

- Realign the crossing and replace the existing culvert with an open-bottom arch with a span of approximately 8 feet to accommodate a future estimated bankfull width of approximately 6.5 feet associated with an estimated 20% increase in bankfull flows due to climate change,
 - This will result in a crossing that meets the Massachusetts River and Stream Crossing Standards, which require a span of 1.2 times the stream's bankfull width.
- The proposed culvert replacement design concept will:
 - Provide increased hydraulic capacity to reduce flooding risk and to allow water and debris associated with larger storms to pass.
 - Decrease potential for road overtopping during heavy precipitation.
 - Reduce geomorphic risk by alleviating the constriction.
 - Improve the passability of the structure.
