# TITUS POND RESTORATION

## WEST-FACING SECTION, LOW-WATER CONDITION

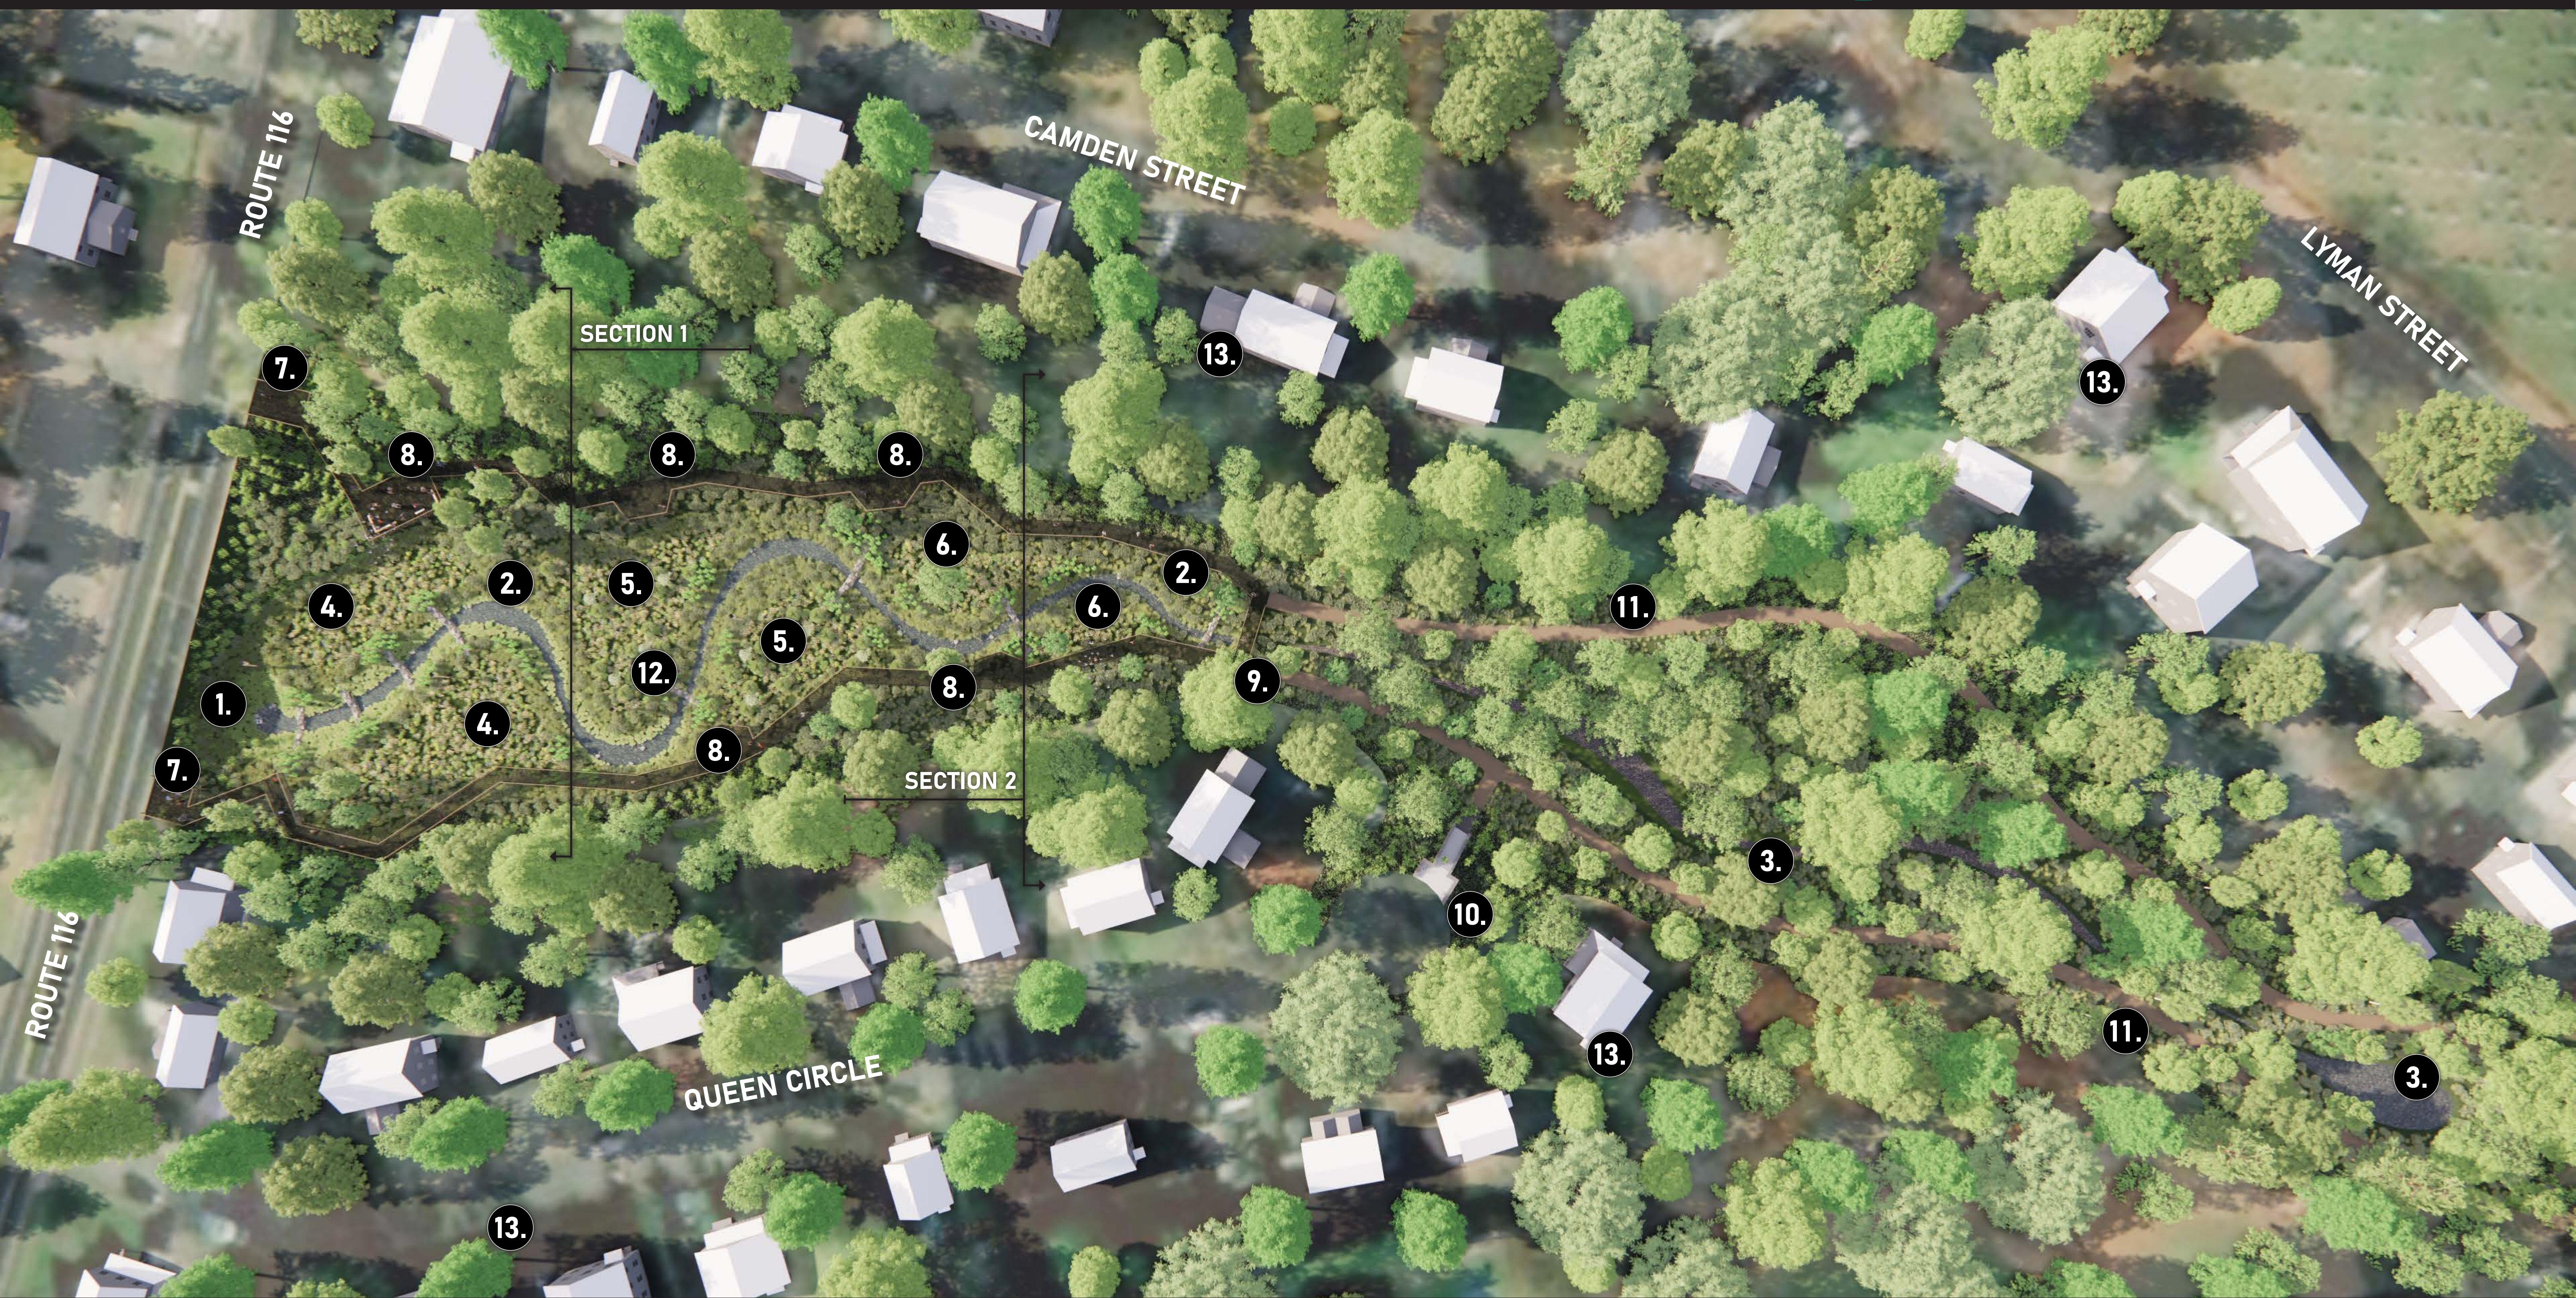
- 1. NEW OUTLET CONFIGURATION
- 2. RESTORED LOW FLOW BUTTERY BROOK STREAM CHANNEL
- 3. EXISTING LOW FLOW BUTTERY BROOK STREAM CHANNEL
- 4. CREATED MARSH WETLAND COMPLEX
- 5. CREATED SCRUB/SHRUB WETLAND COMPLEX
- 6. CREATED FORESTED WETLAND COMPLEX
- 7. TRAIL HEAD OVERLOOK BOARDWALK CONNECTION TO SIDEWALK AT ROUTE 116

- 8. BOARDWALK OVERLOOK WITH SEATING AND EDUCATIONAL SIGNAGE
- 9. BOARDWALK STREAM CROSSING
- 10. QUEEN CIRCLE TRAIL HEAD
- 11. NATURAL SURFACE LOOP TRAIL EXTENSION
- 12. IN STREAM GRADE CONTROL STRUCTURES CONSTRUCTED WITH NATURAL MATERIALS  
- SUCH AS, NATIVE ROUNDED BOULDERS, LOGS, ROOTWADS, ETC.)
- 13. EXISTING RESIDENTIAL STRUCTURES

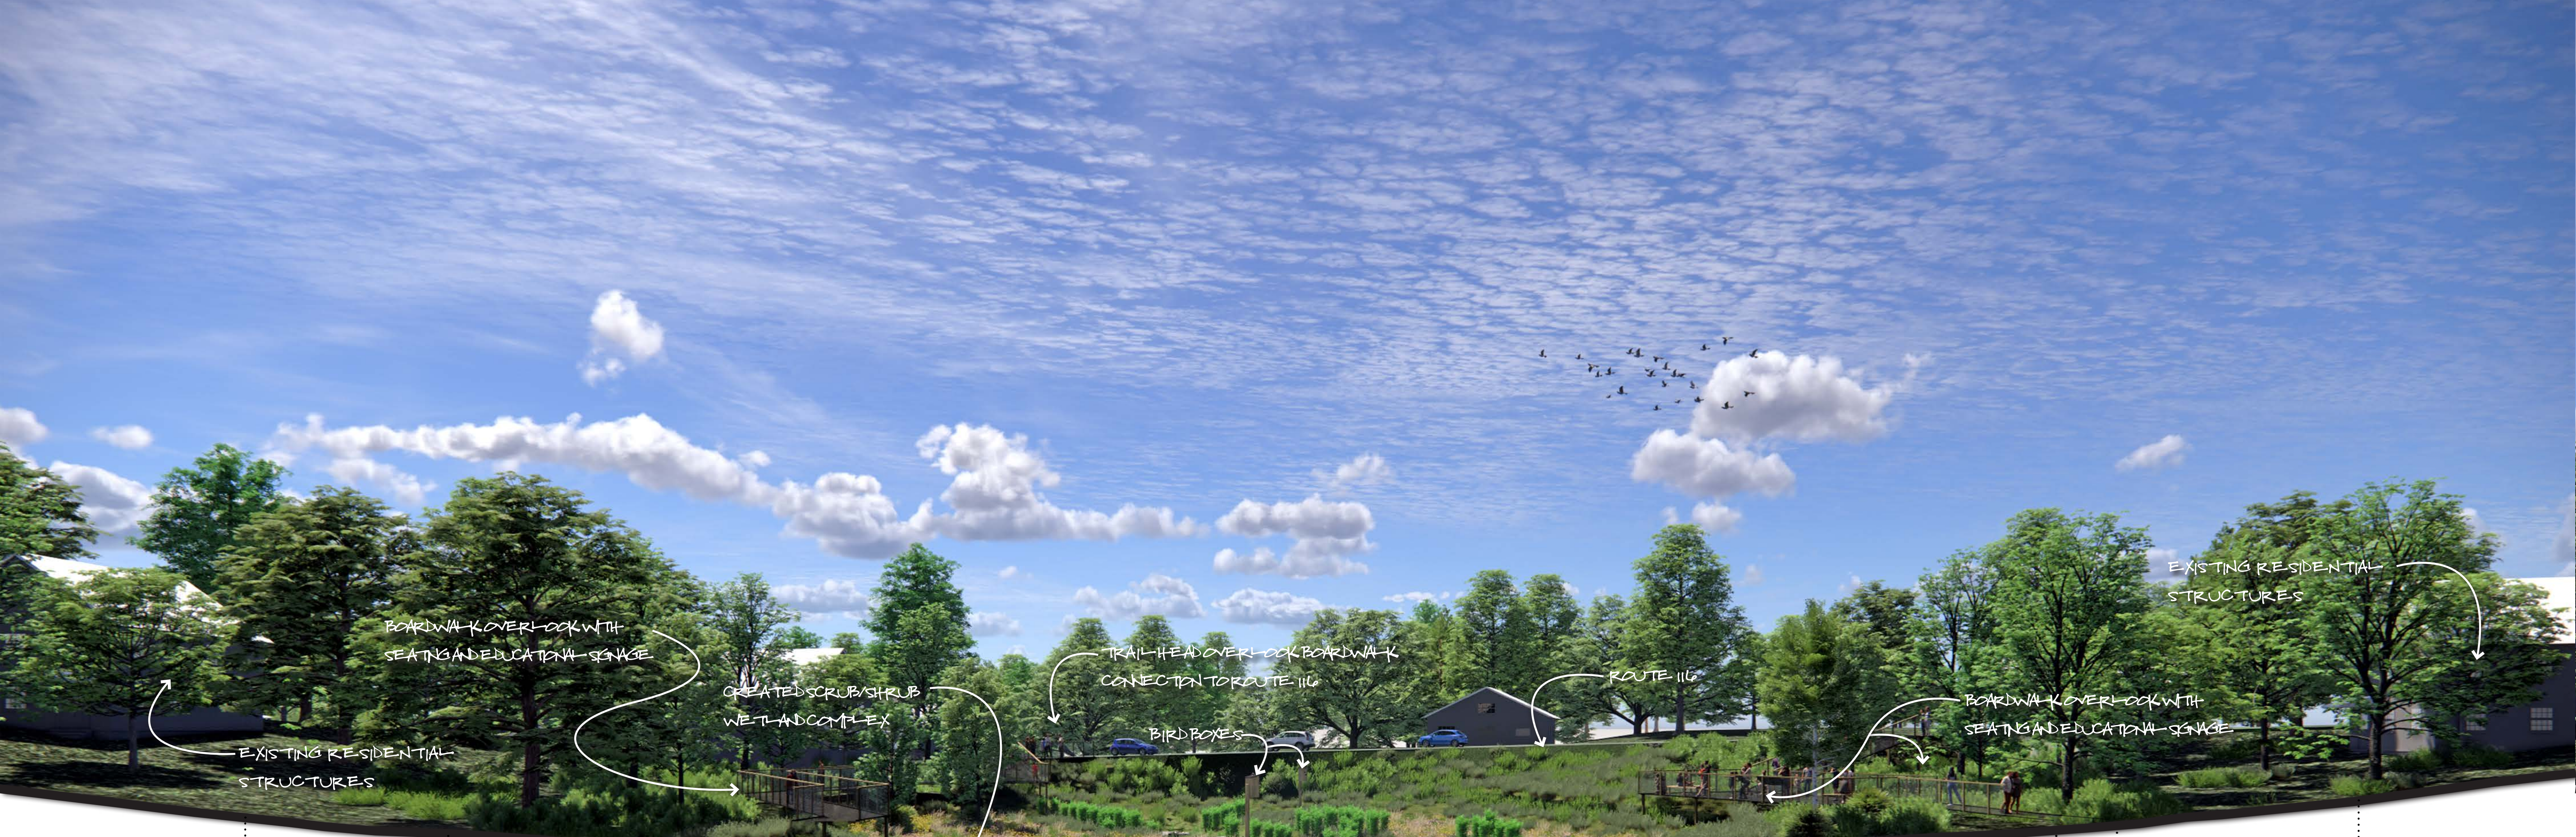
SECTION 1

BOARDWALK OVERLOOK WITH SEATING AND EDUCATIONAL SIGNAGE

CREATED SCRUB/SHRUB WETLAND COMPLEX

TRAIL-HEAD OVERLOOK BOARDWALK CONNECTION TO ROUTE 116

BIRD BOXES

REFORESTED UPLAND ZONE

PONDED AREA DURING LARGE STORM EVENT

CREATED MARSH WETLAND

MULTI-USE BOARDWALK

BERMED WETLAND BUFFER ZONE

BUTTERY BROOK STREAM PROFILE

ENHANCED MID BANK PLANTINGS

WETLAND PLANTING AREA

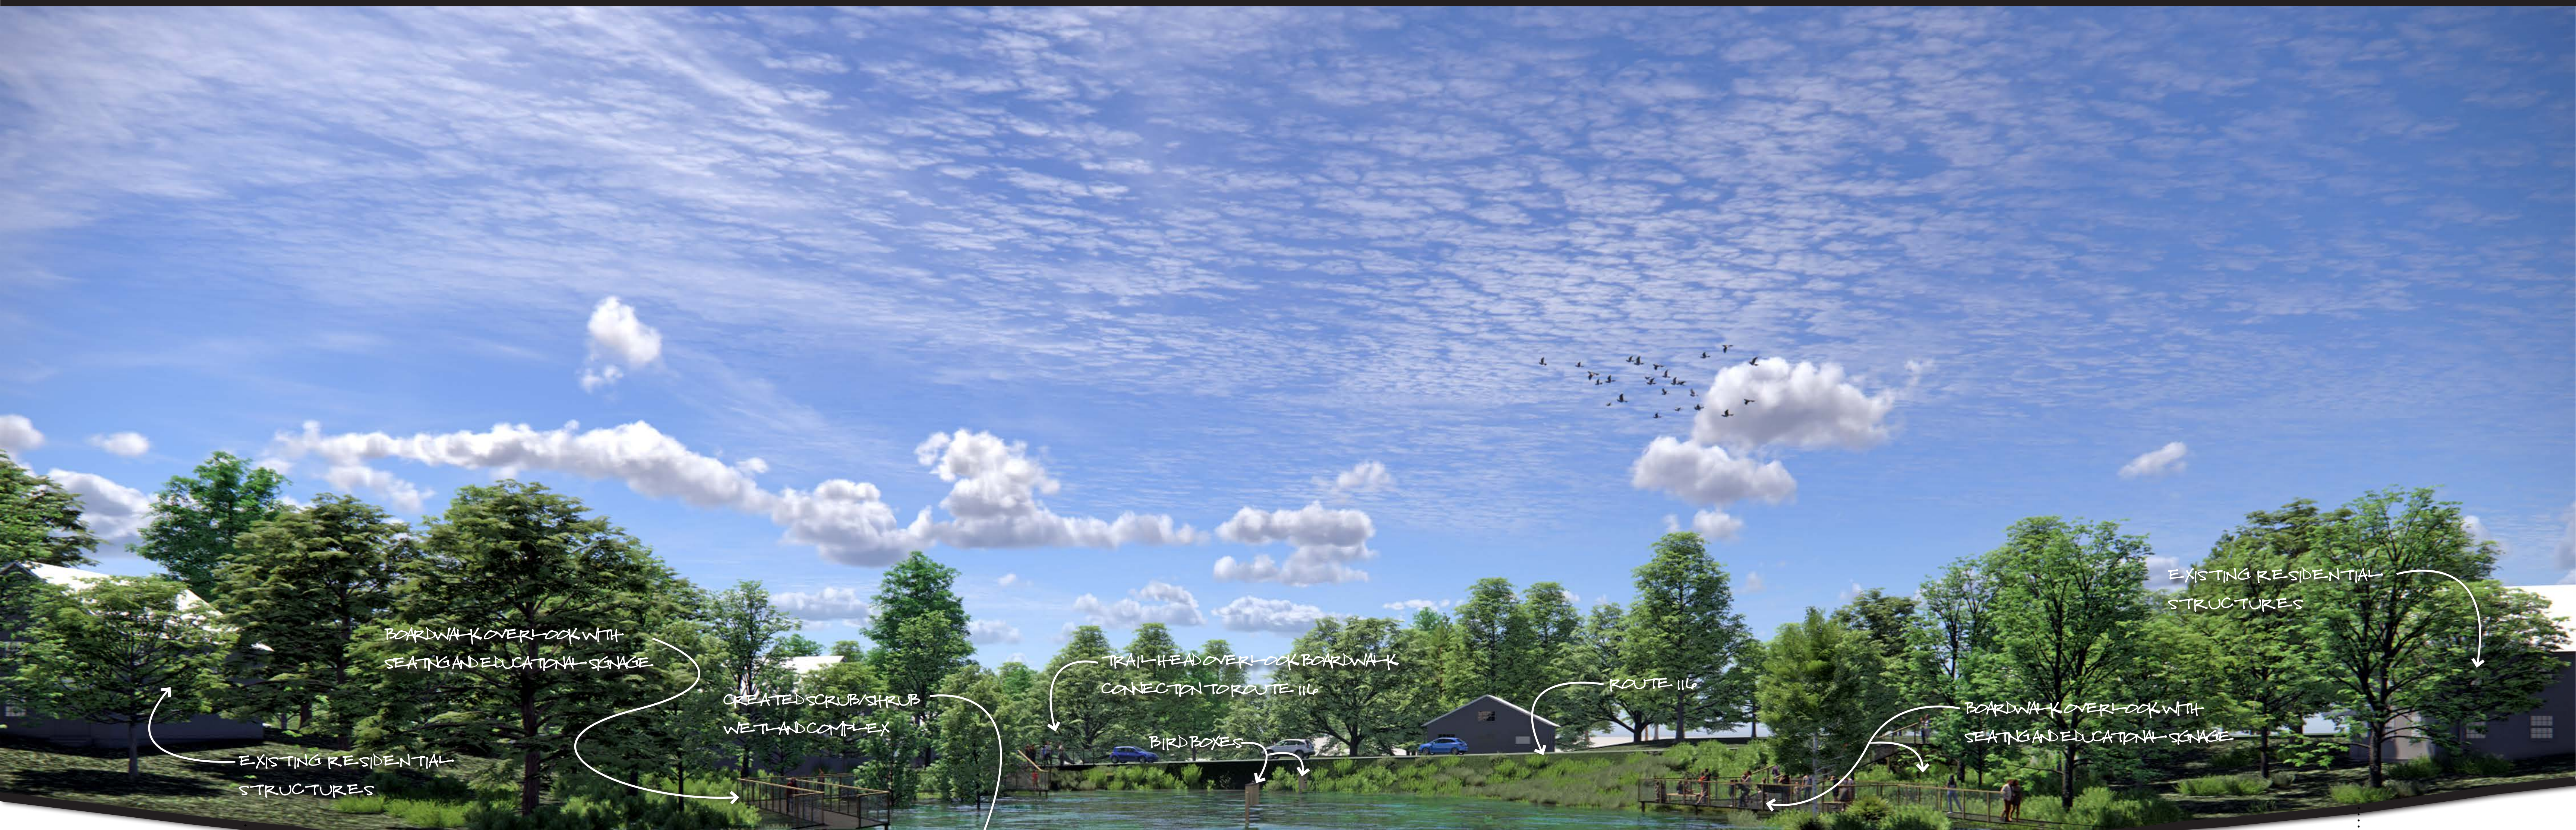
SECTION 1

## WEST-FACING SECTION, DURING LARGE STORM EVENT

REFORESTED UPLAND ZONE

PONDED AREA DURING LARGE STORM EVENT

CREATED MARSH WETLAND

MULTI-USE BOARDWALK

BERMED WETLAND BUFFER ZONE

BUTTERY BROOK STREAM PROFILE

ENHANCED MID BANK PLANTINGS

WETLAND PLANTING AREA

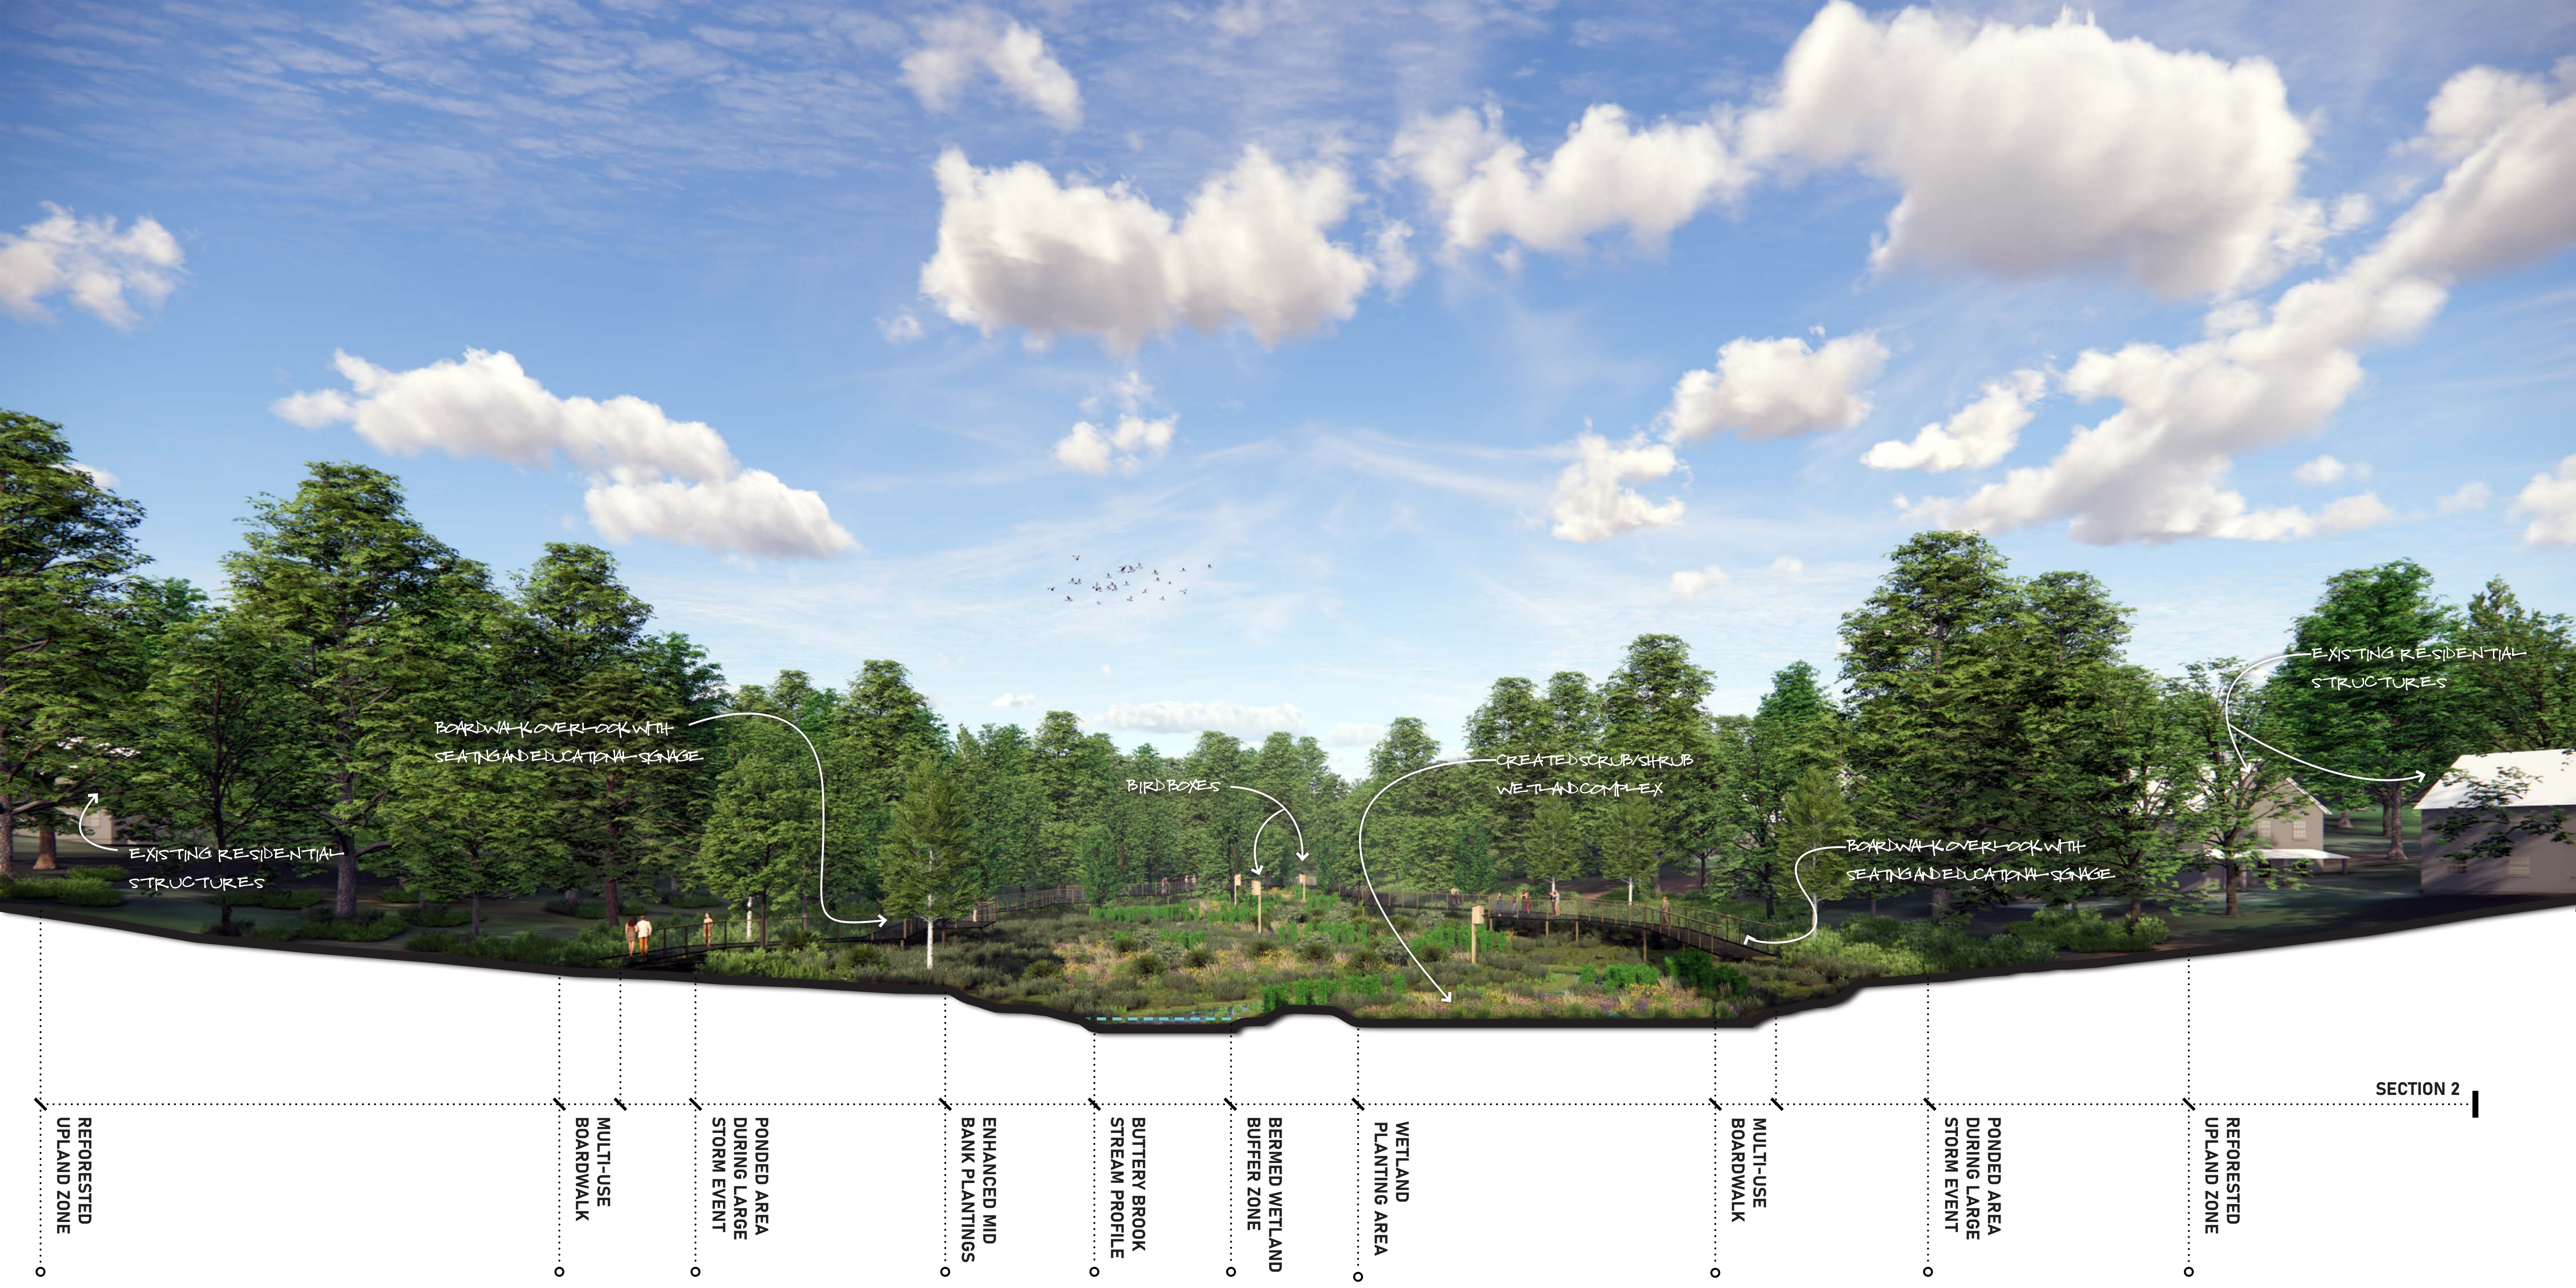
## EAST-FACING SECTION, LOW-WATER CONDITION

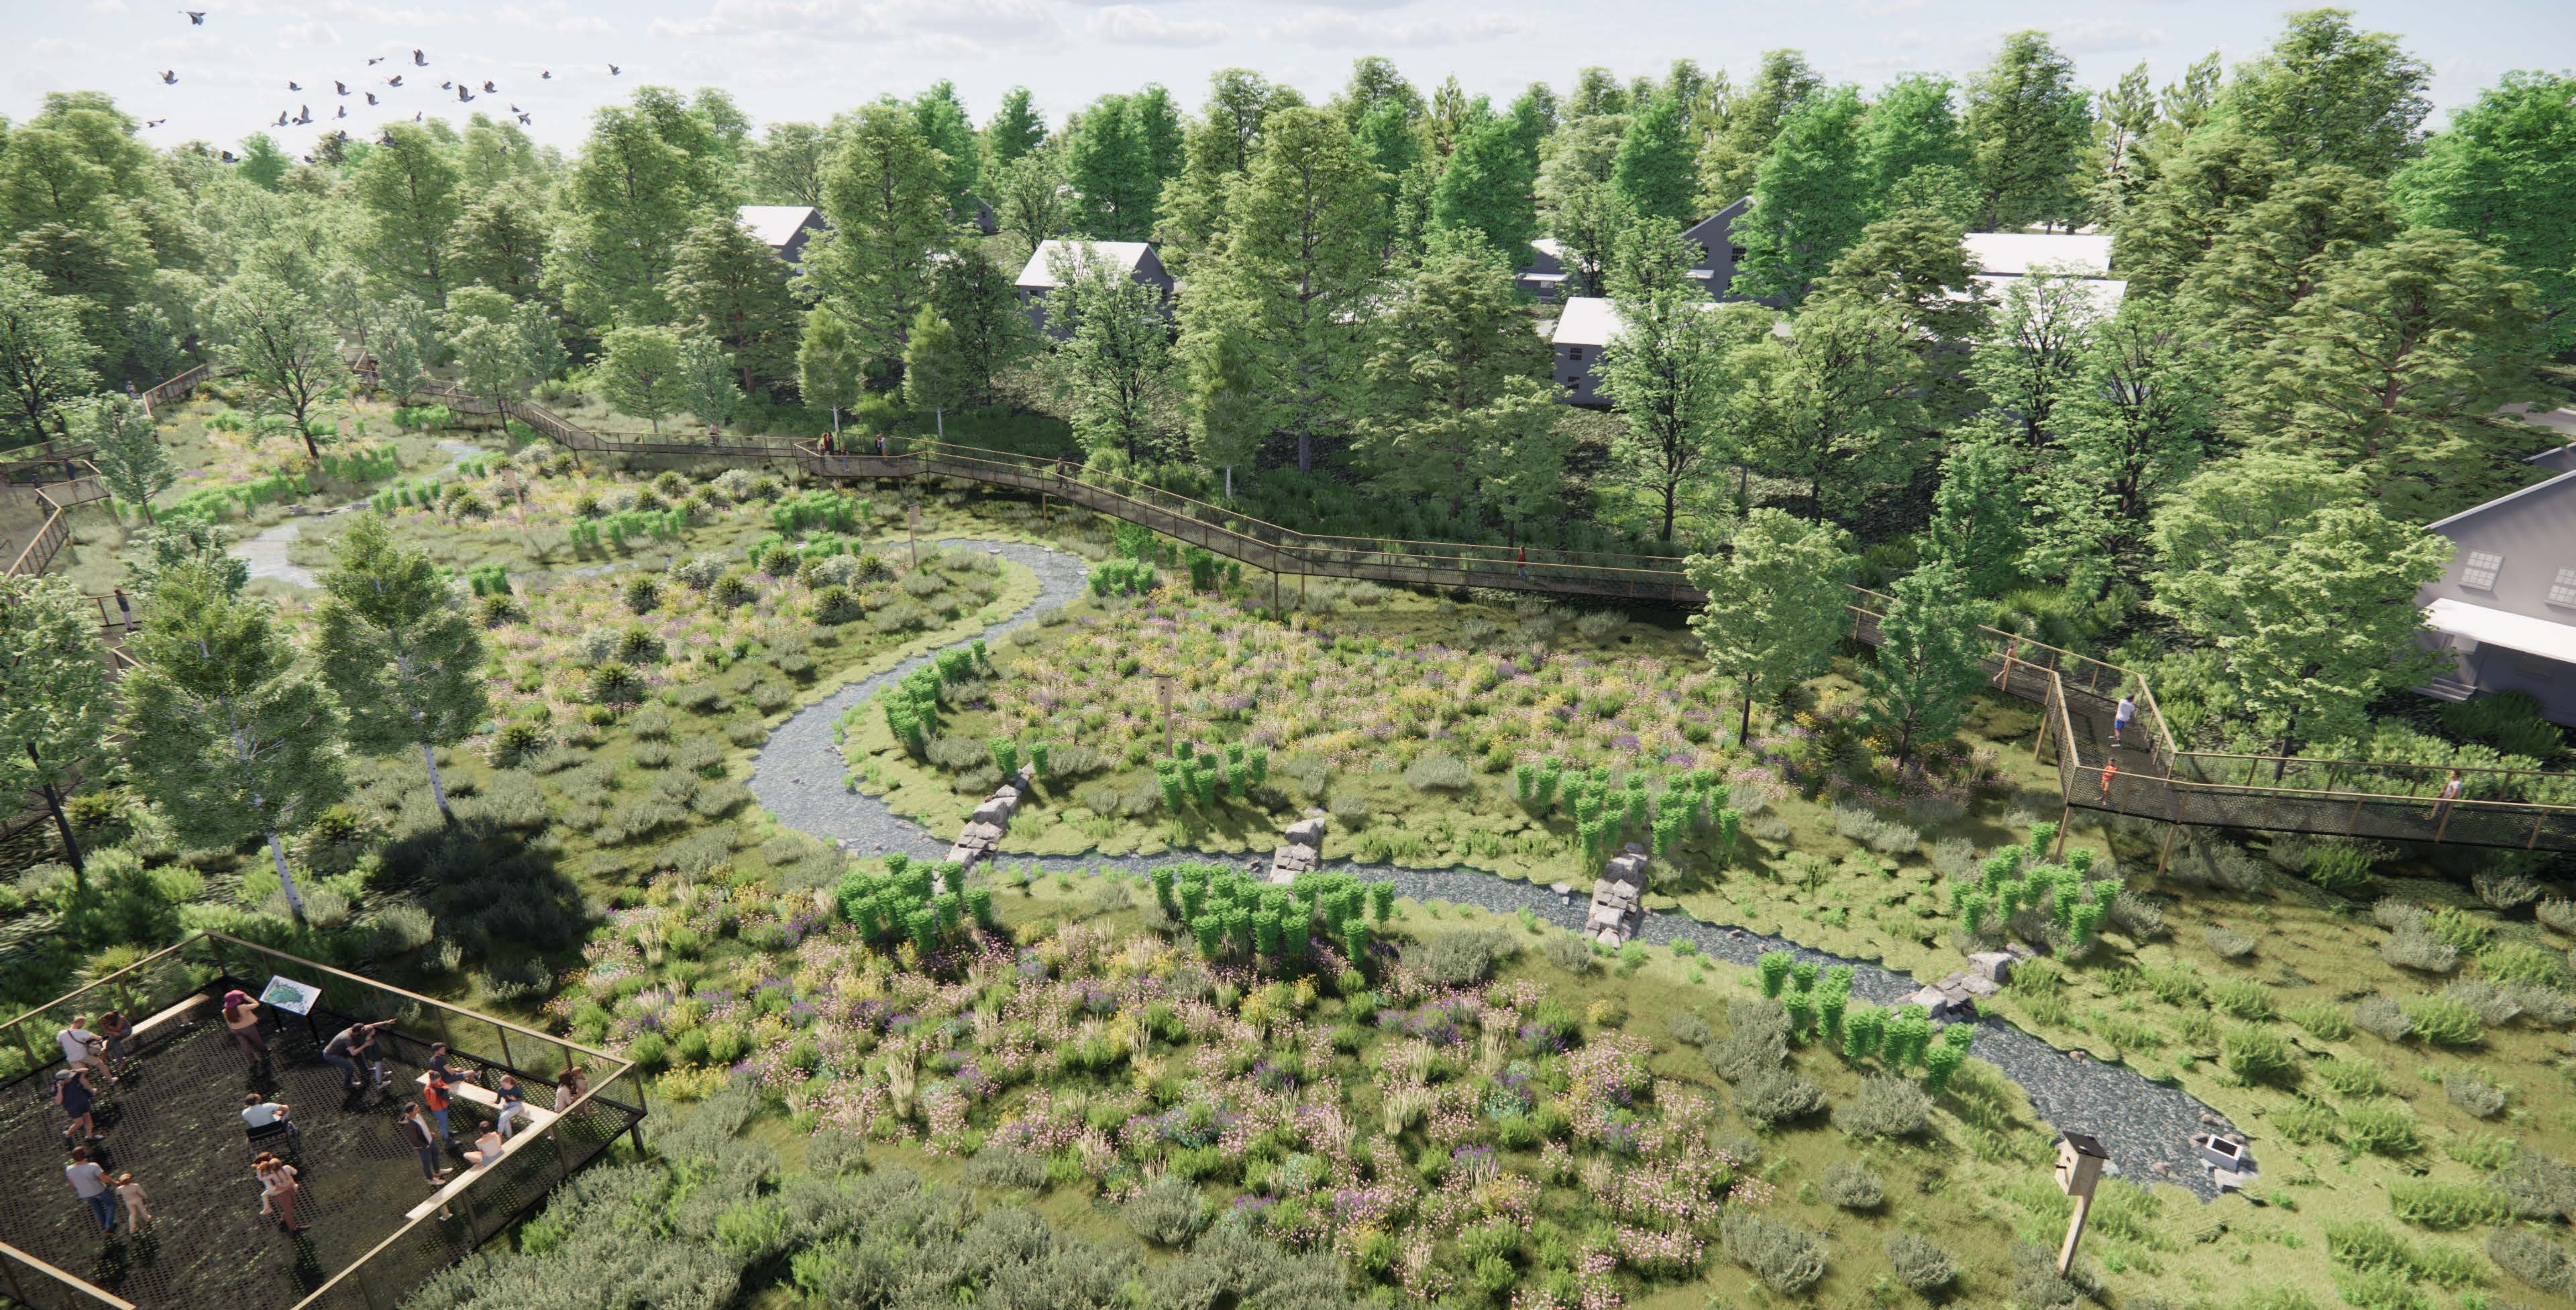
BIRDSEYE VIEW FACING SOUTHEAST, LOW-WATER CONDITION

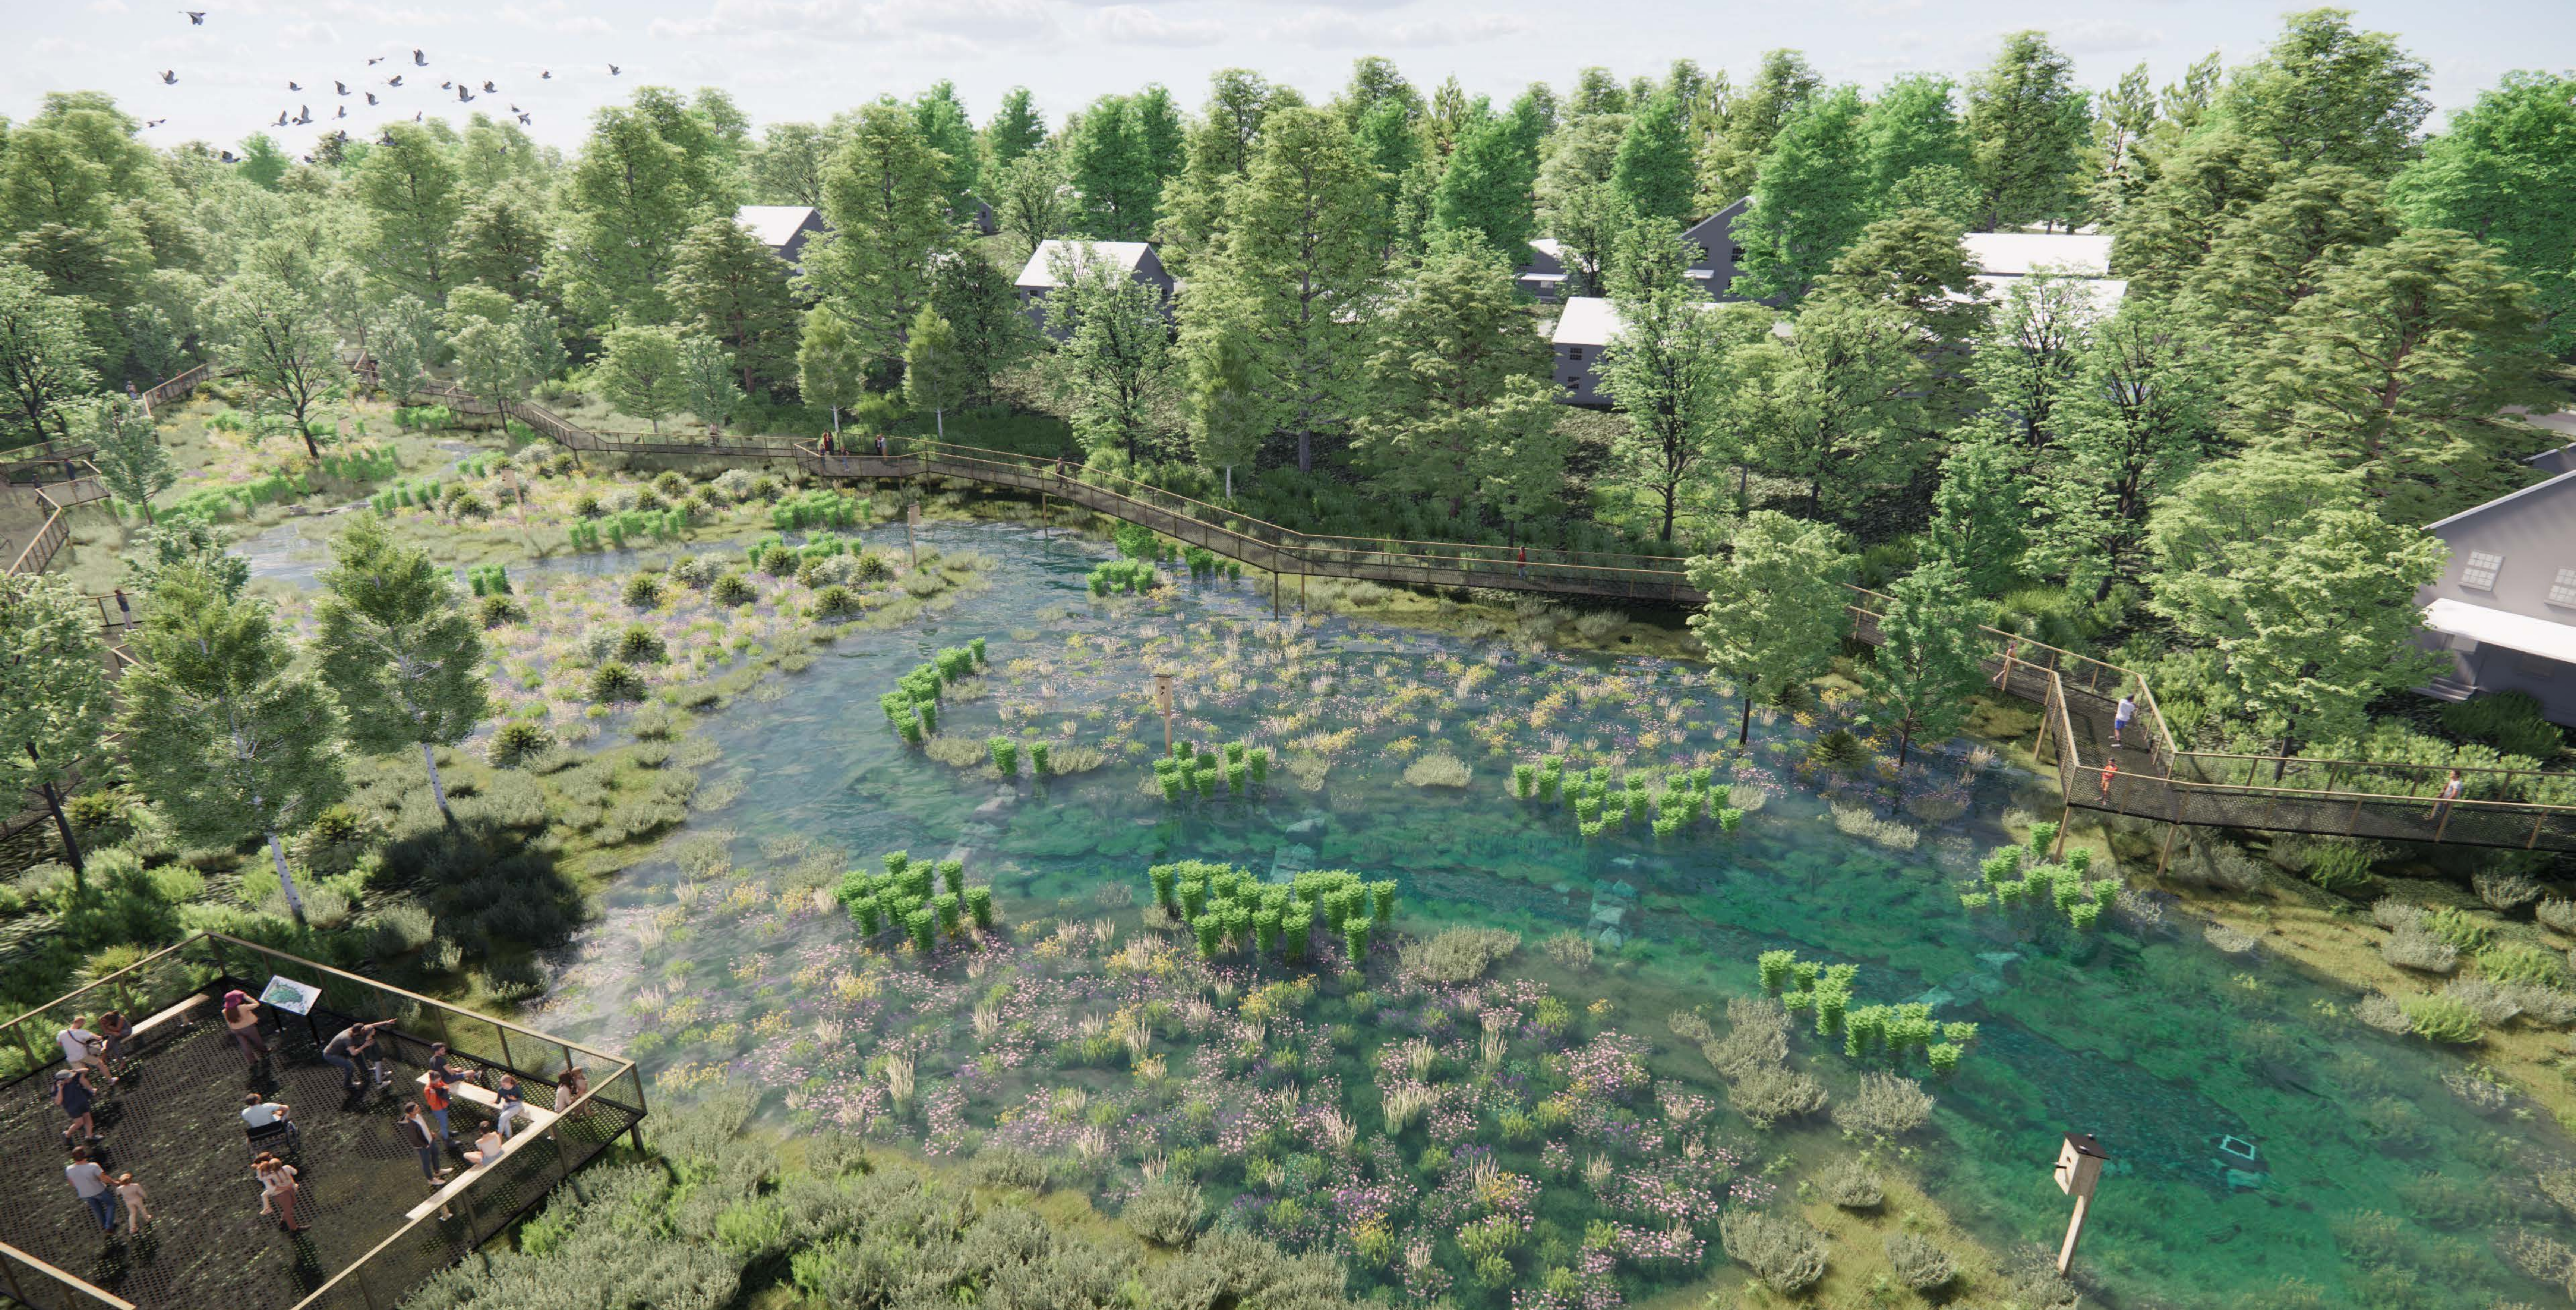
BIRDSEYE VIEW FACING SOUTHEAST, POOLED WETLAND CONDITION

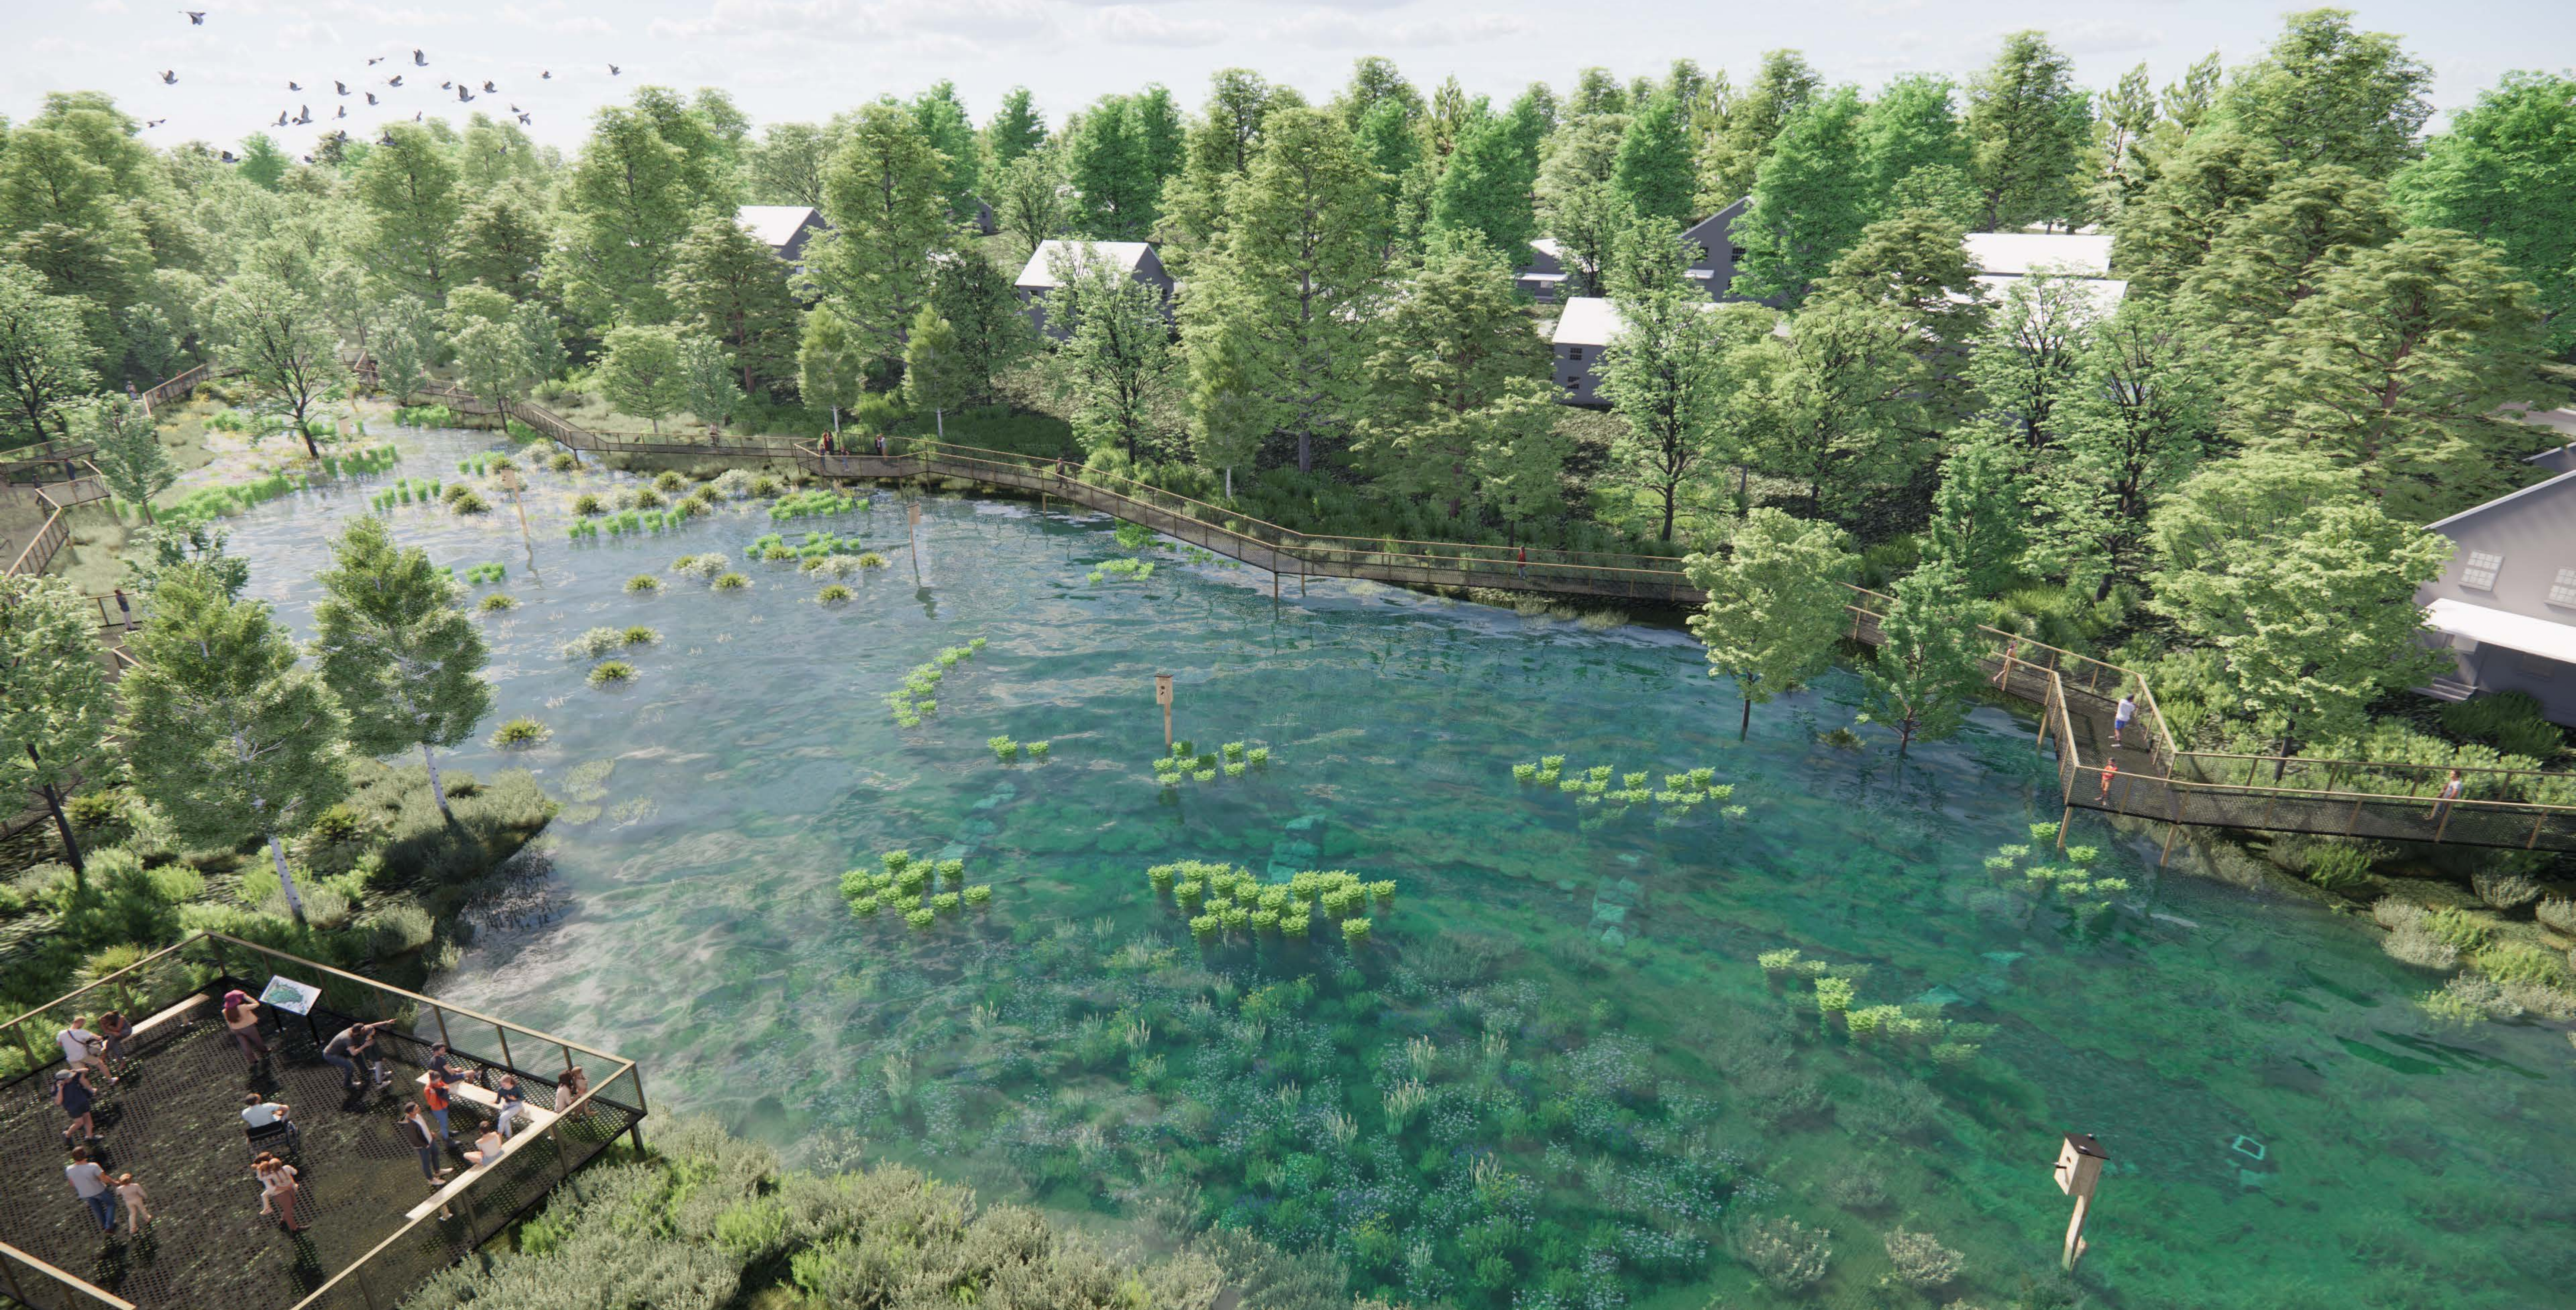
BIRDSEYE VIEW FACING SOUTHEAST, DURING LARGE STORM EVENT
